IN THE COURT OF CLAIMS OF OHIO

AFFIDAVIT OF ERIC MOSER

Re: Grand Valley Local Schools Roof Study

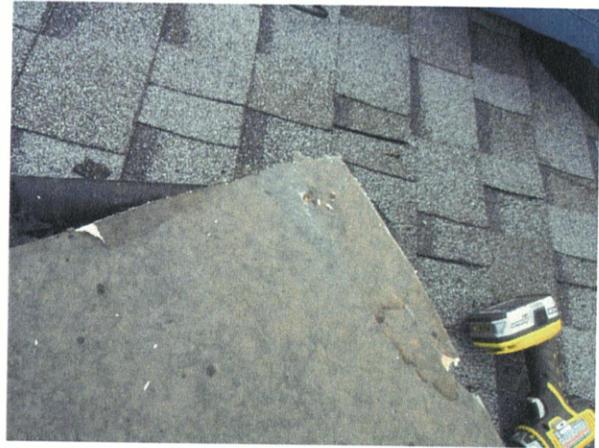
Past moisture stains were also observed on the underside of the bottom layer of insulation.

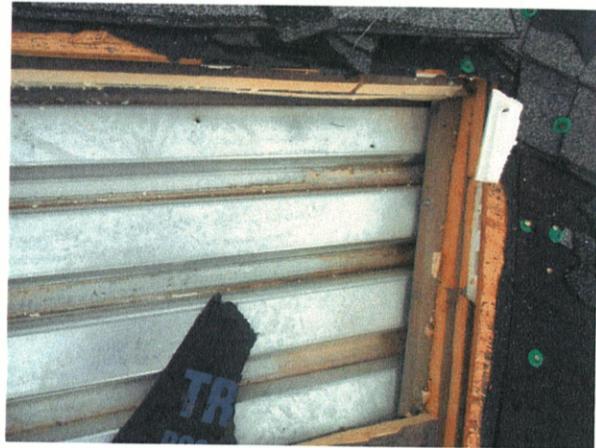
The bottom layer of insulation was removed and it observed that there was evidence of past moisture present in the low ribs of the deck.

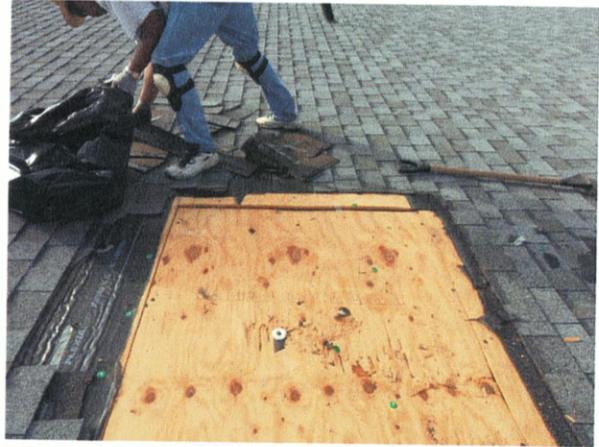
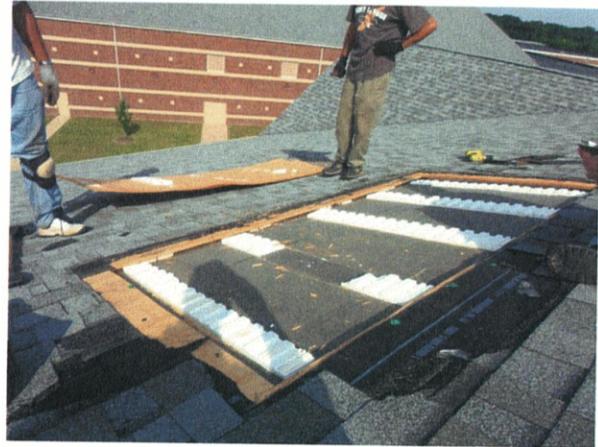
Once the fasteners were removed the plywood warp of the board was more pronounced.

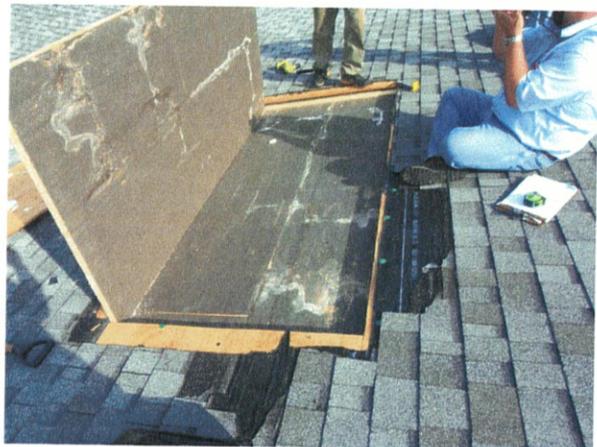
Significant staining was present on the facers between the vented board and the underlying 1.5" polyisocyanurate insulation board.

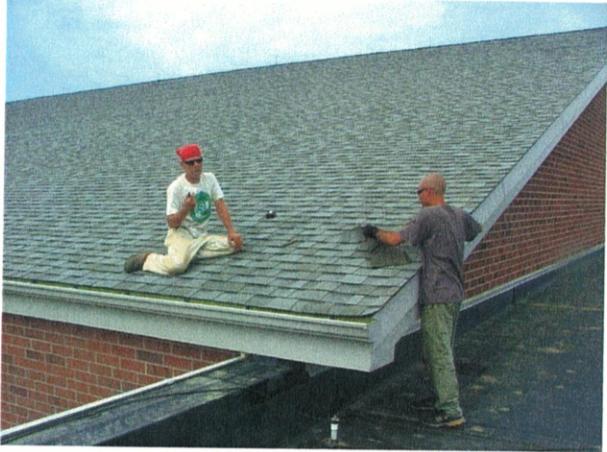
Roof Test Opening #5

The northeast corner of the Varsity Gym was the location of RTO #5. This area was chosen to view the components at a soffit at a fall hazard safe condition.

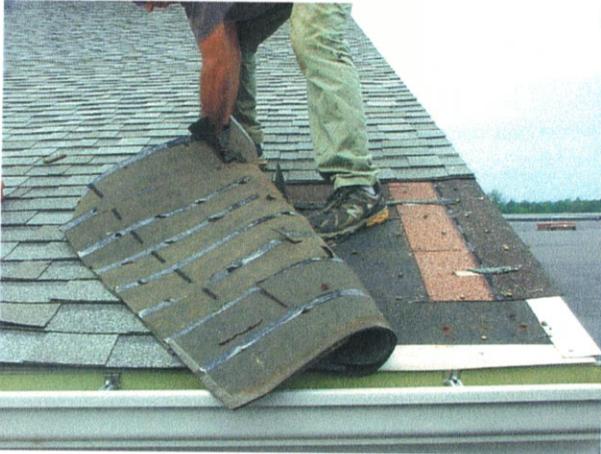
As the shingles were removed it was observed that while a starter shingle was installed up the rake, but no bituthene was present. In addition, the bituthene present at the gutter was installed to a distance 34" up from the gutter and 28" from the exterior face of the exterior wall. Ohio Building Code requires the underlayment to be installed a minimum of 24" inches from the interior of the exterior wall. This installation does not comply with this requirement.

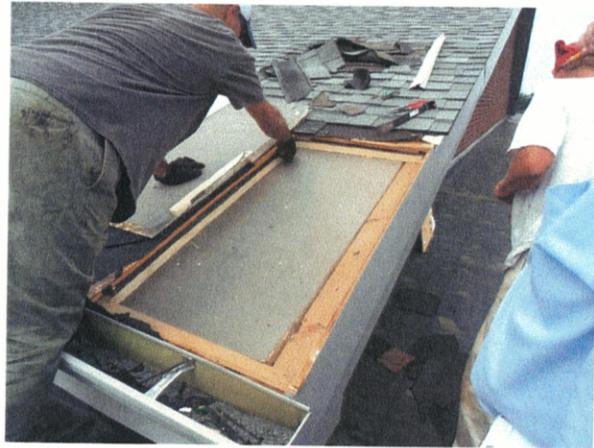
No signs of deterioration were observed on the plywood or the facers on the insulation.

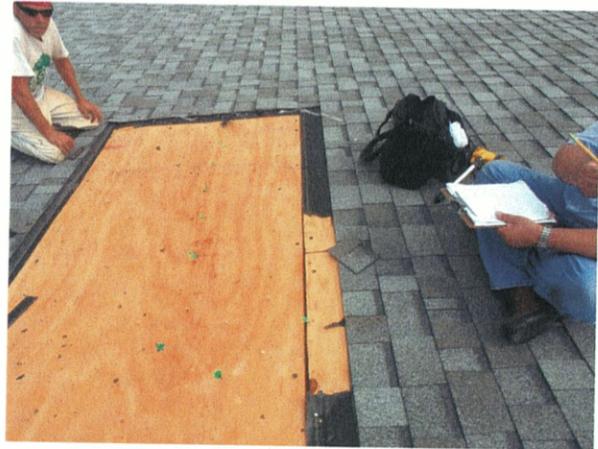
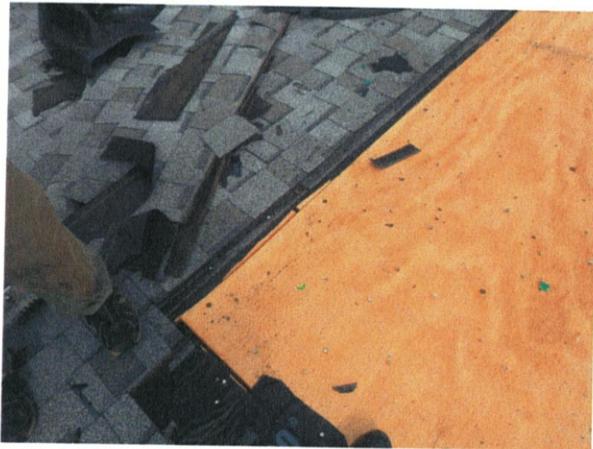
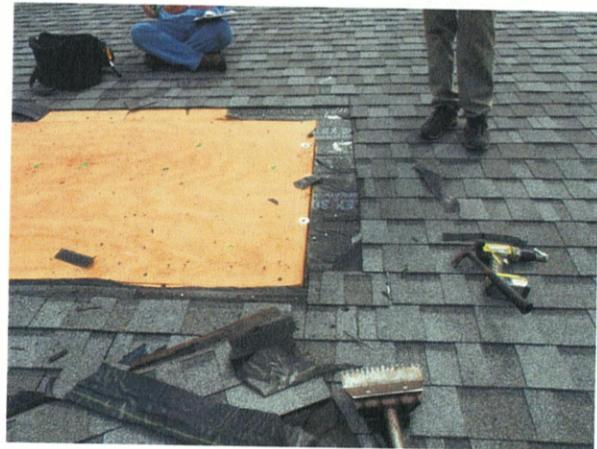
It was observed that a 5/8" gap was present along the top of the board, a 3/8" gap was present on the left hand side of the board, and 1/8" gaps were present on the bottom and right hand side of the board. This appeared to be sufficient gapping.

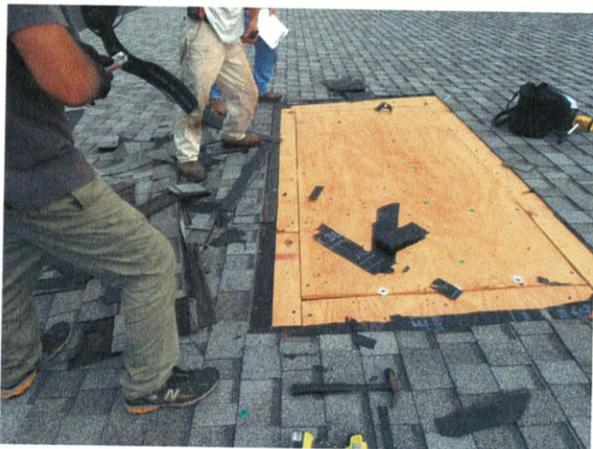
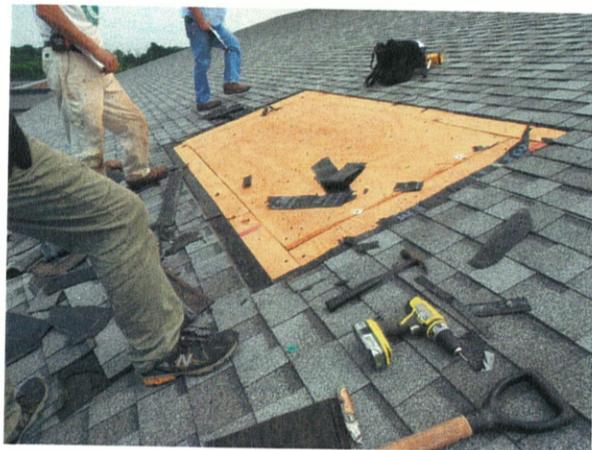
On the right hand side of the board, it was observed that three additional fasteners with plates were installed in an apparent attempt to pull down the curled end of the board. It was observed that the board was bowed in-between the fasteners.

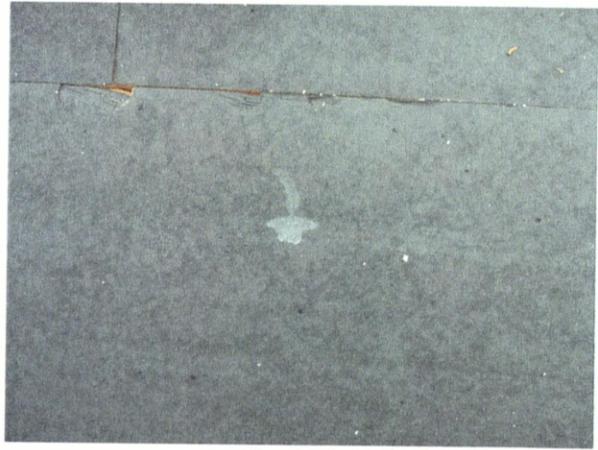
Evidence of apparent biological growth was observed on the bottom of the insulation of the vent board and on the top of the bottom layer of insulation.

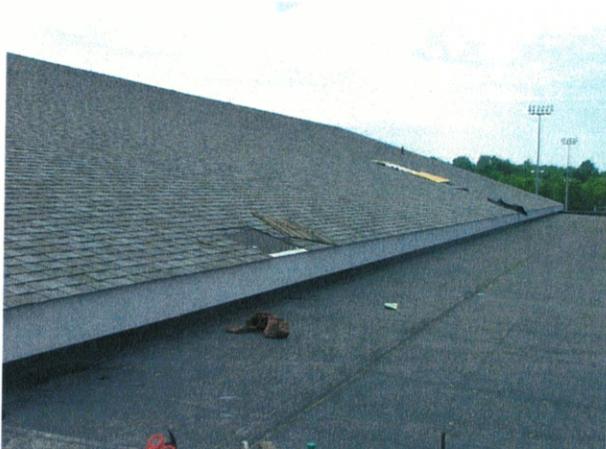
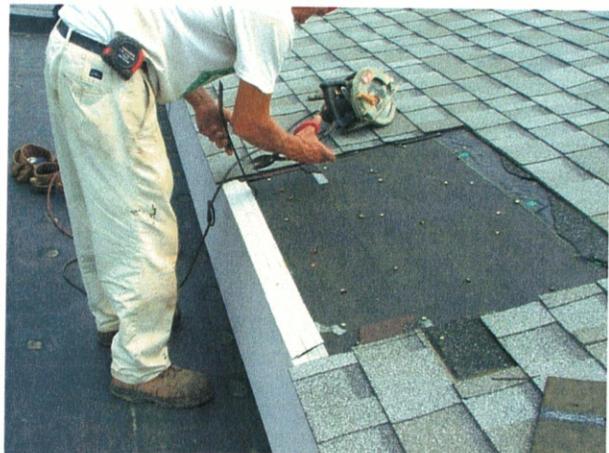
Roof Test Opening #7

RTO was located at the north end of the west face of Roof D. The shingles were removed at this location to investigate the soffit intake and roof ventilation components in a safe location.

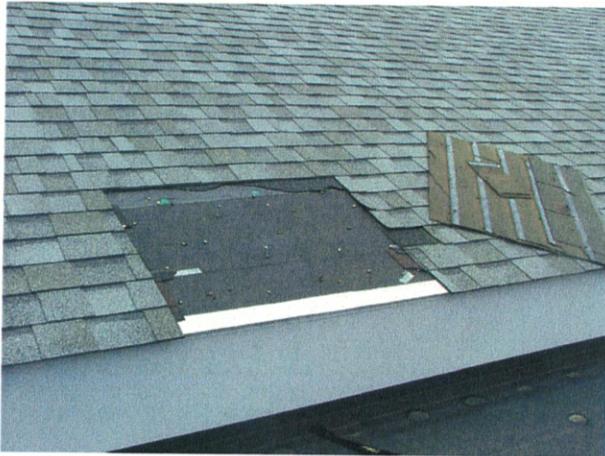
Once the shingles were removed the bituthene was again present, extending up the roof 34" from the gutter edge and 28" from the exterior face of the exterior wall. Again, this was not sufficient; the bituthene is required to extend 24" in from the interior of the exterior wall per Ohio Building Code.

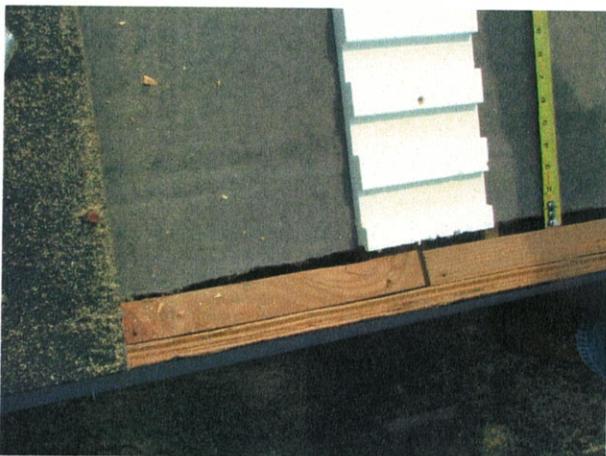
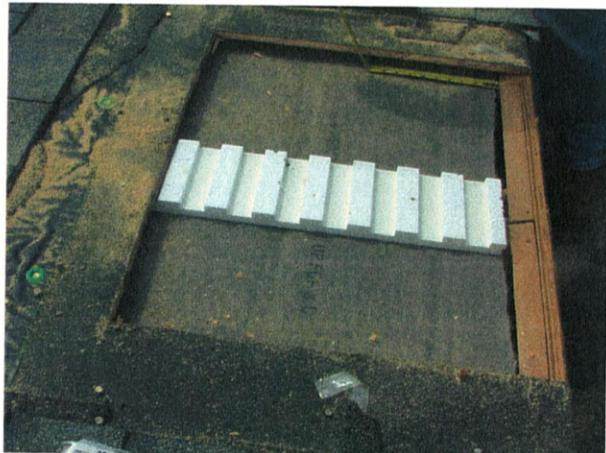
The air space opening behind the wood fascia varies from a maximum of 1" to -0-". This condition will inhibit adequate air from ventilating through the roof assembly.

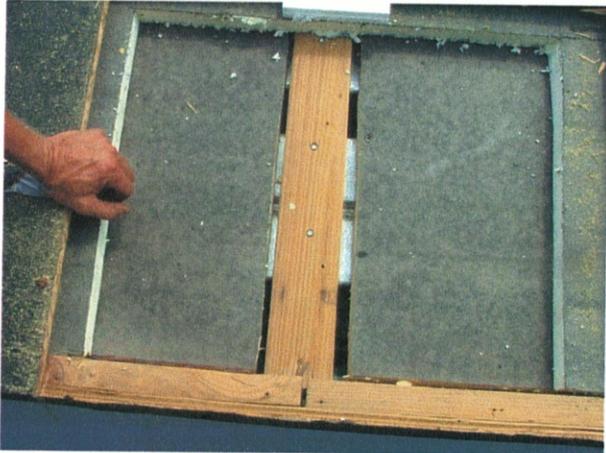
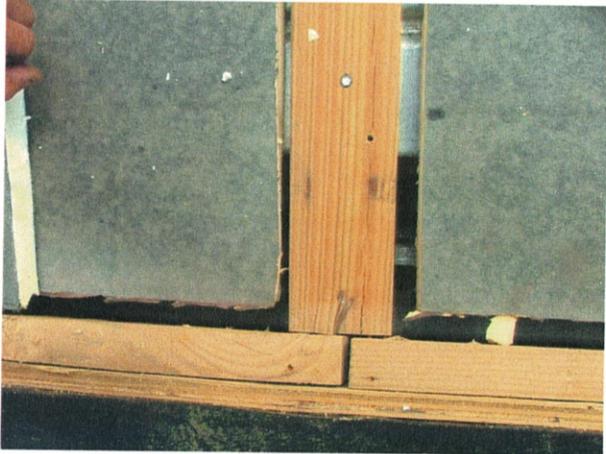
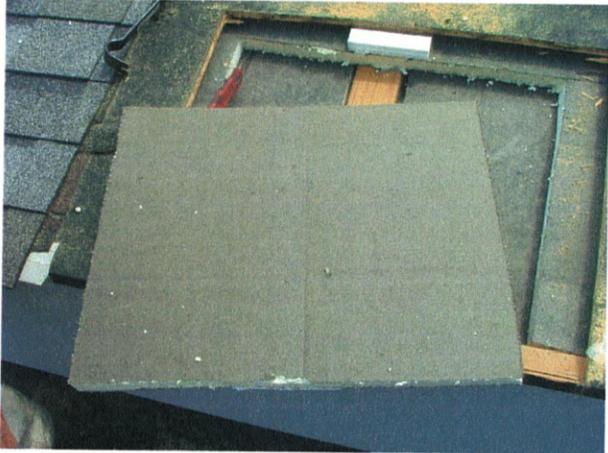
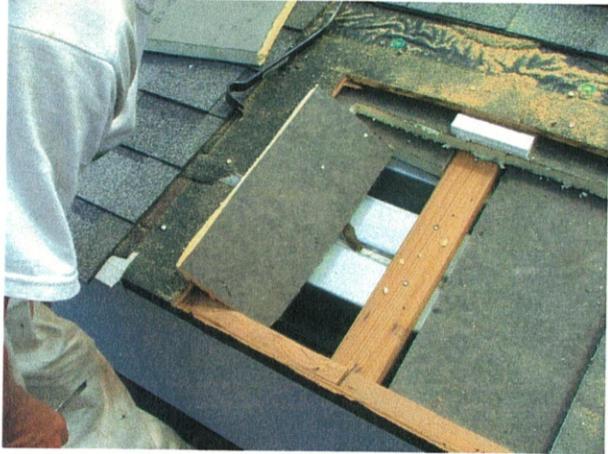
Gaps were present adjoining the sleeper wood present at the soffit. These larger gaps may allow excess heat loss and contribute to the reported ice damming.

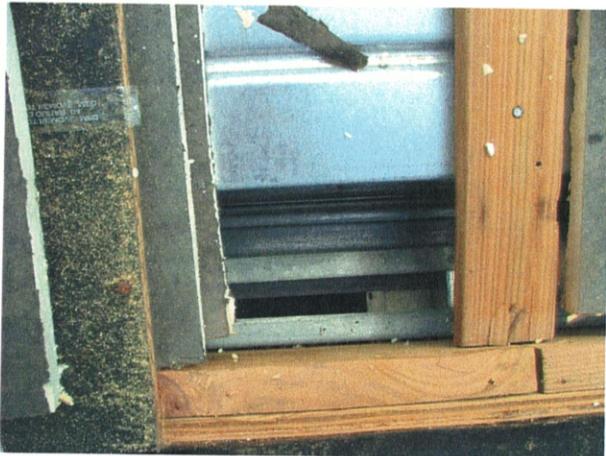
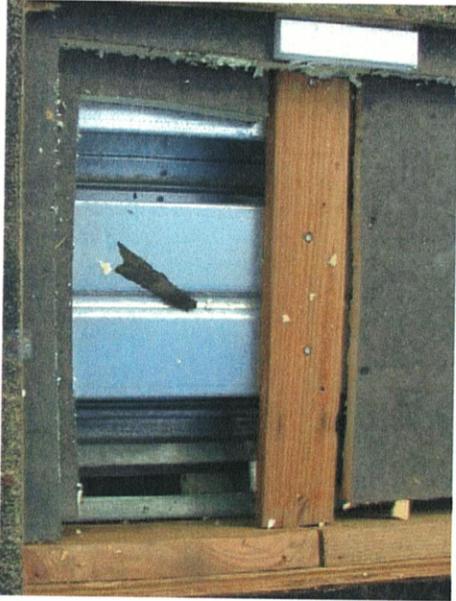
With the removal of all the insulation it was observed that an approximate 1.5" opening is present between the framing to allow air passage at the soffit.

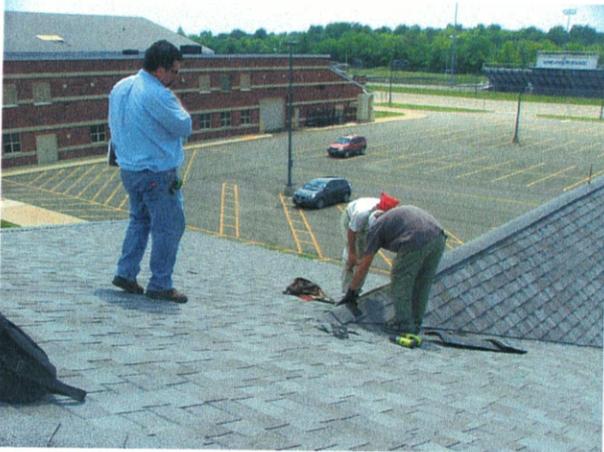
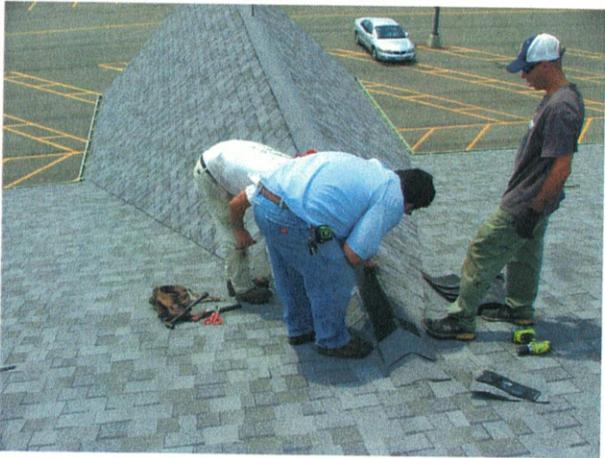
Roof Test Opening #8

RTO # 8 was located on Roof F at the eastern most dormer, on the southern side of the roof. The roof was opened to expose the transition between the main roof and the dormer roof.

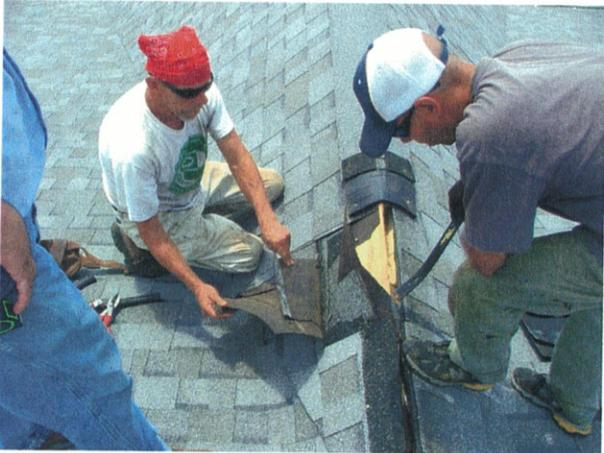
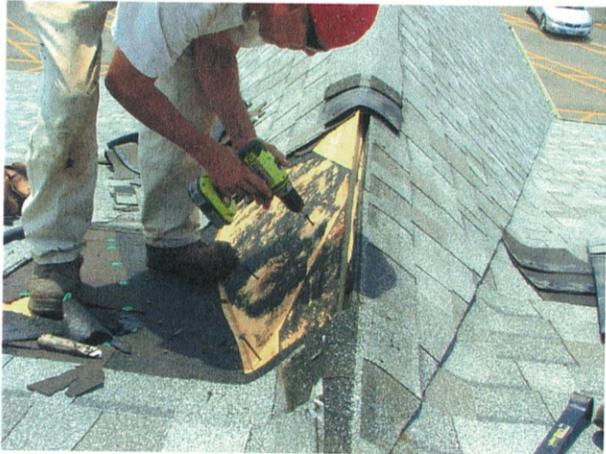
The ridge was opened and it was observed that an approximate 2" opening was present. Further it was observed that the insulation was not mitered at the peak creating a point of heat loss.

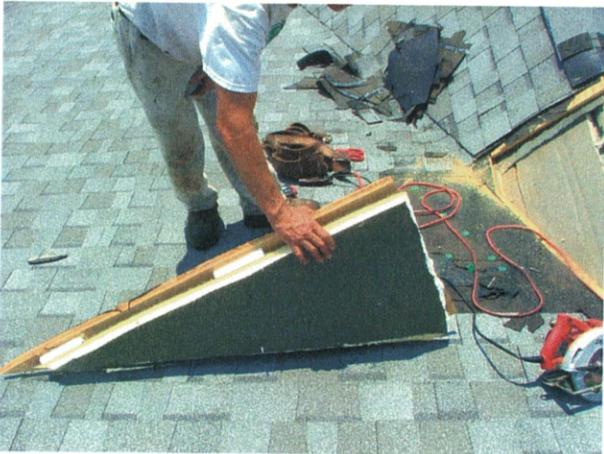
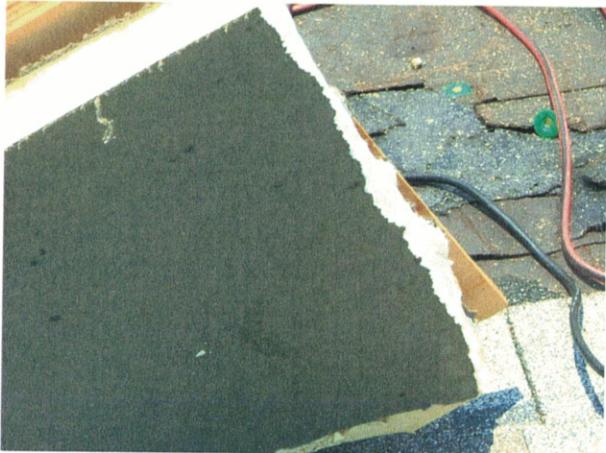
On the bottom facer of the insulation board of the vent board staining was observed. This could likely be from condensation.

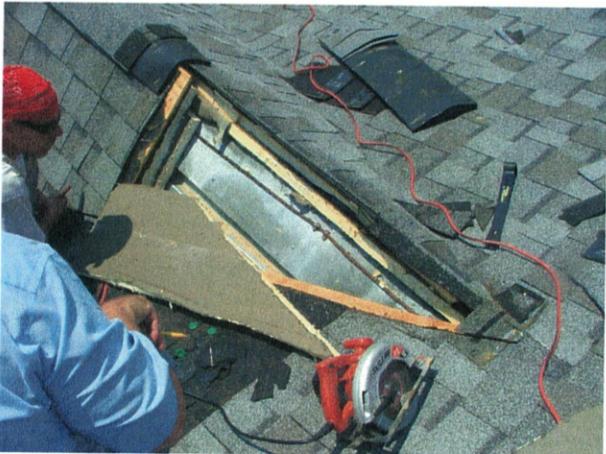
Once the vent board and insulation was removed it was observed that the copper lightning rod cable was mounted to the galvanized steel deck. A galvanic reaction appears to have already developed were the two dissimilar metals have been in contact.

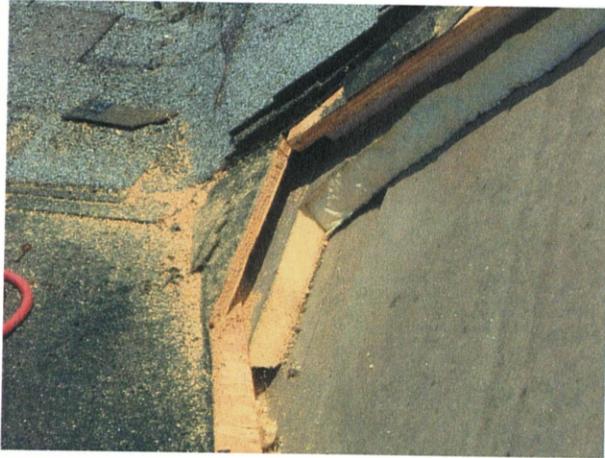
As part of the removal of the insulation from the dormer it was observed that the plywood from the main field of the roof tightly abuts the base layer of insulation on the dormer, preventing air transfer from between the two venting board. In addition, no gap was left for expansion of the plywood.

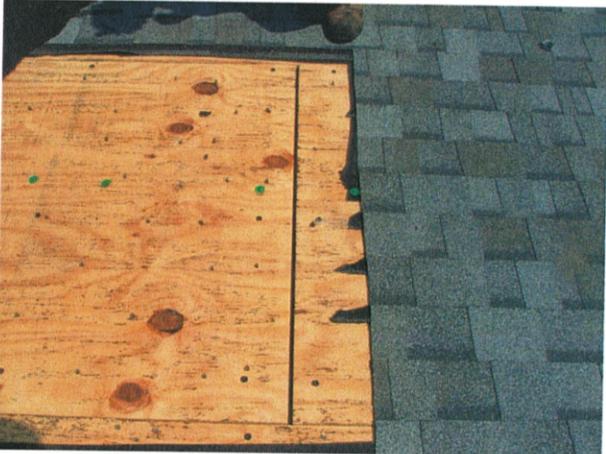
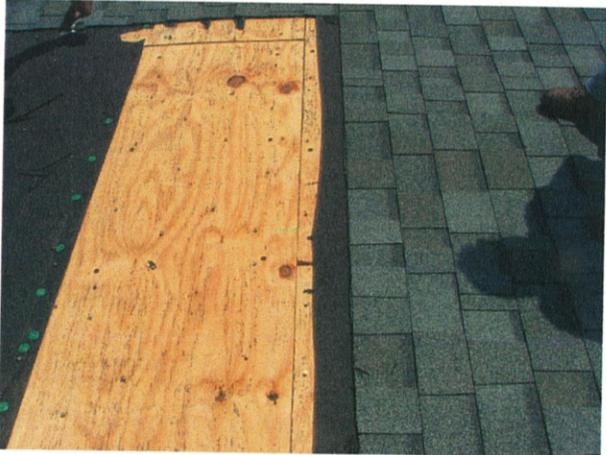
The gap present around the perimeter of the board was inconsistent. It ranged from 3/8" on two sides to nothing on the other two sides. The lack of a 1/8" on two sides may have contributed to the bowing of the plywood.

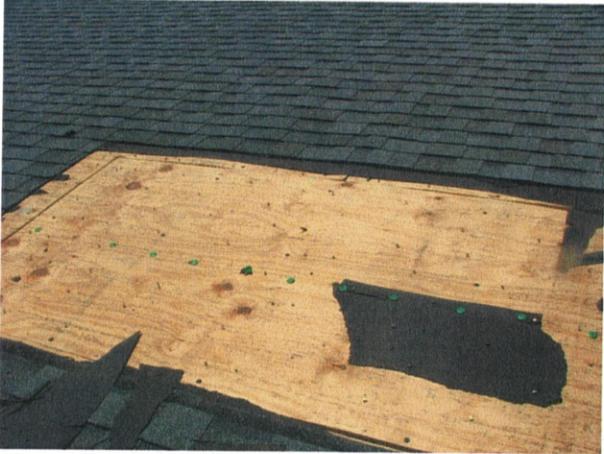
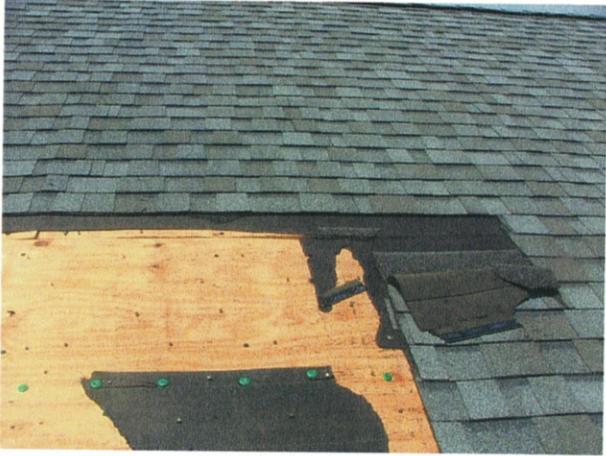
It was also observed that plywood had become warped and bowed.

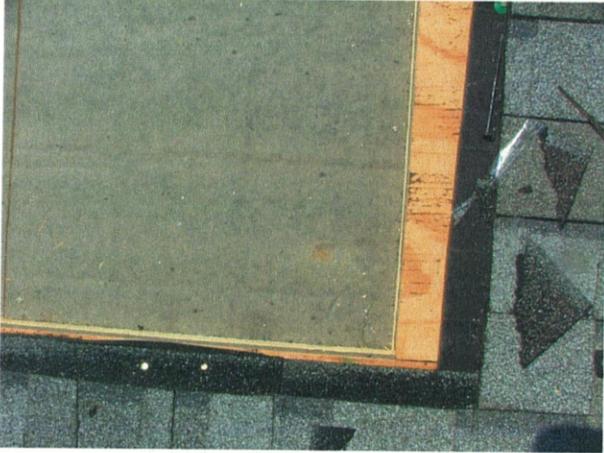
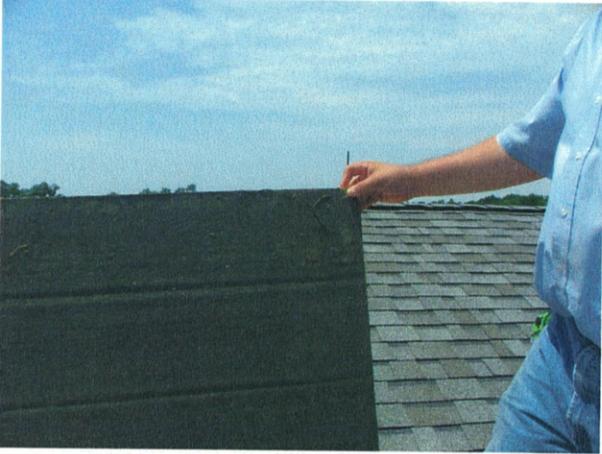
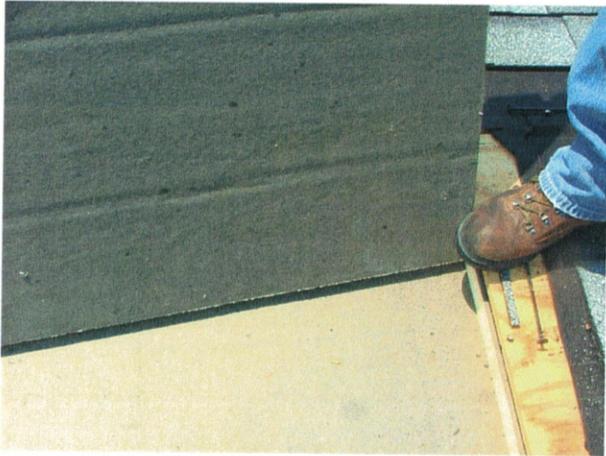
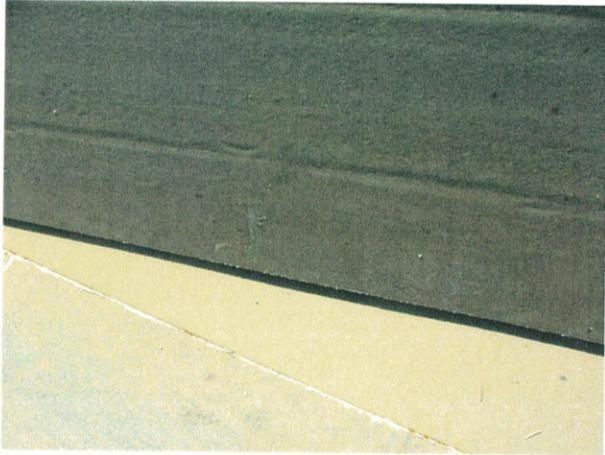
Once the plywood and insulation was removed it was observed that an apparent biological growth and past moisture stains were present on the facers between the layers of insulation.

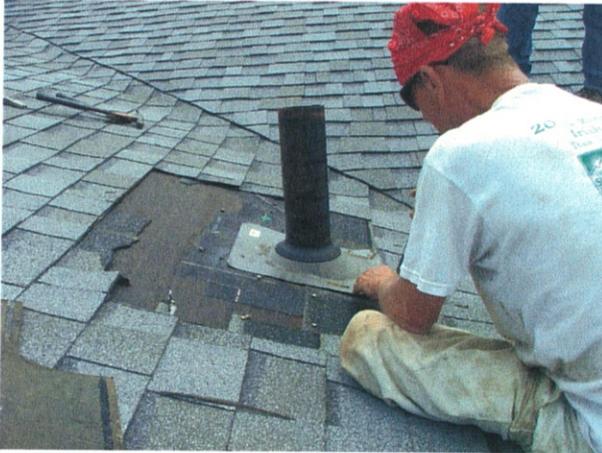
Roof Test Opening #10

RTO #10 was created around a soil stack on Roof F as shown on the drawing. This was created to determine if the roof assembly was sealed around the stack penetration.

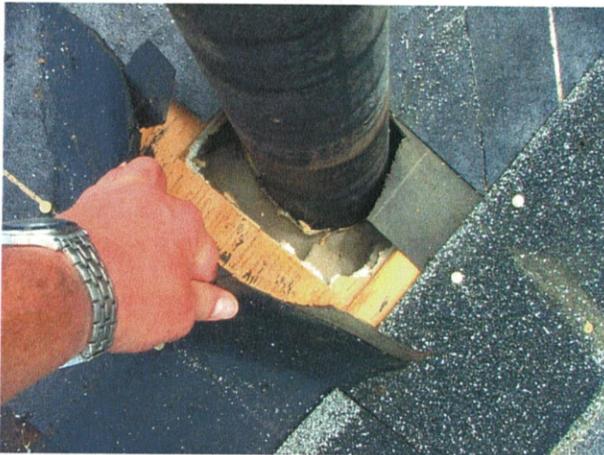
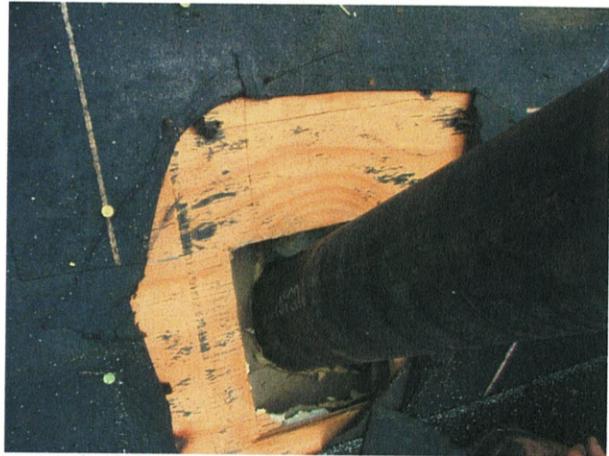
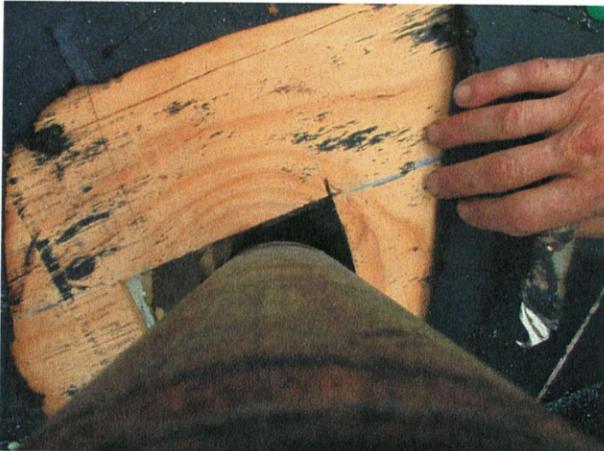
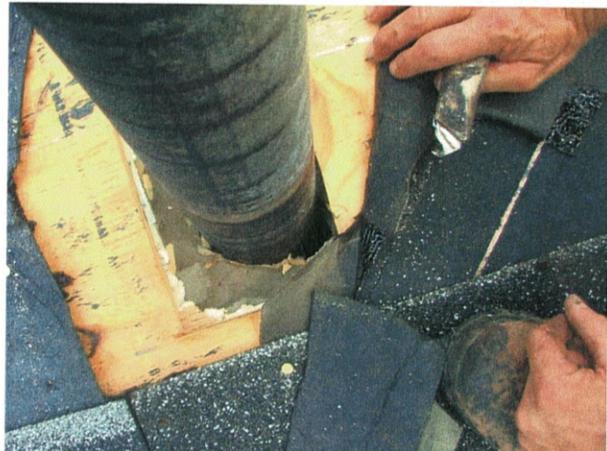
After the shingles, flashing boot, and underlayment were removed a large gap was observed between the soil stack pipe and the surrounding plywood, insulation, and deck. As a result, interior conditioned air can readily escape into the roof assemblies vent space.

This gapped condition may cause ice damming to form in cold weather conditions. In addition, it allows conditioned air to readily escape which is energy inefficient.

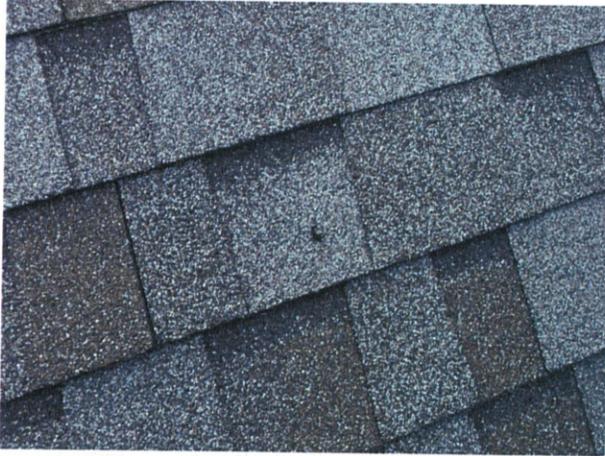
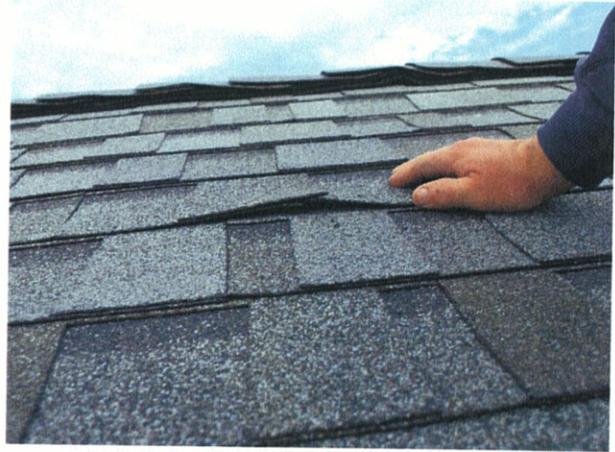
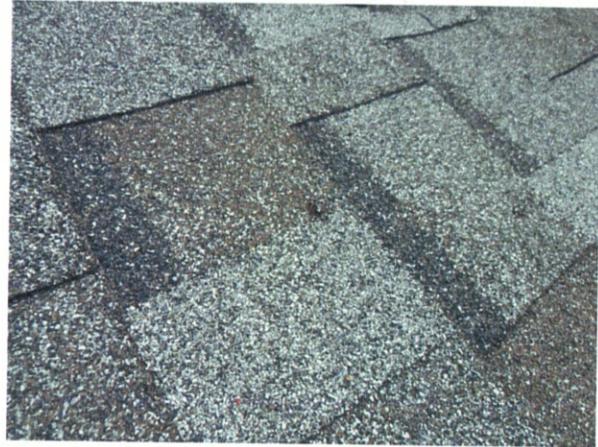
The nails used for securing the shingles were cadmium coated nails which are not an approved nail per Table 1507.2 that requires galvanized, stainless steel, aluminum, or copper nails be used.

The specifications and submittals for the project were not reviewed therefore it is uncertain what nails were specified or approved. The fasteners present have begun to rust in areas and will continue to deteriorate, especially at the locations of ice damming and leaks. In addition, throughout the roof areas nails have backed out and created holes in the overlying shingles. Each of these “nail pops” are potential points of moisture entry.

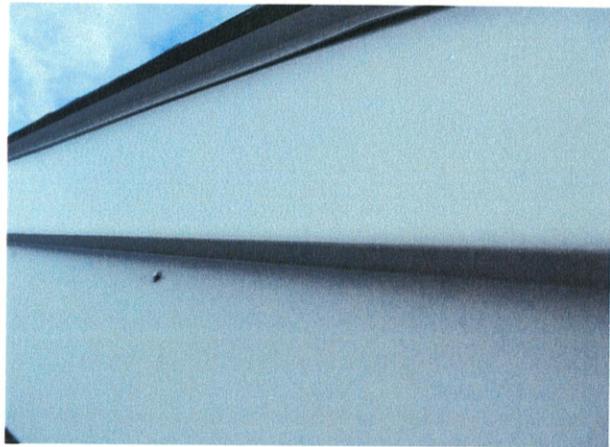
Areas were observed where exposed nails were installed to secure the fascia metal. These nails are backing out. Exposed nails should not be present in fascia since they create points of entry for moisture.

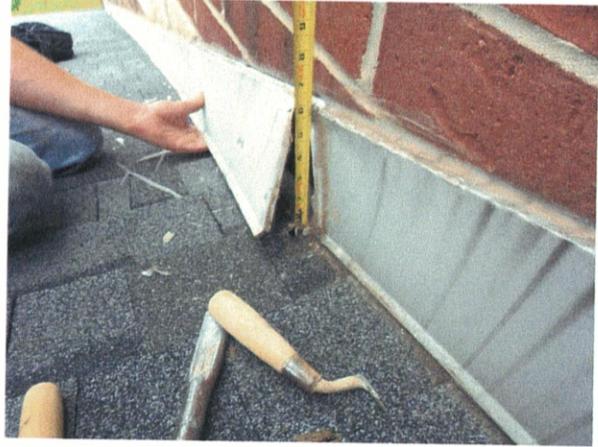
As a result of the moisture entry the sheet metal flashing was removed from the masonry wall. Once partially removed it revealed that the step tins present only had an approximate 2" up turned leg.

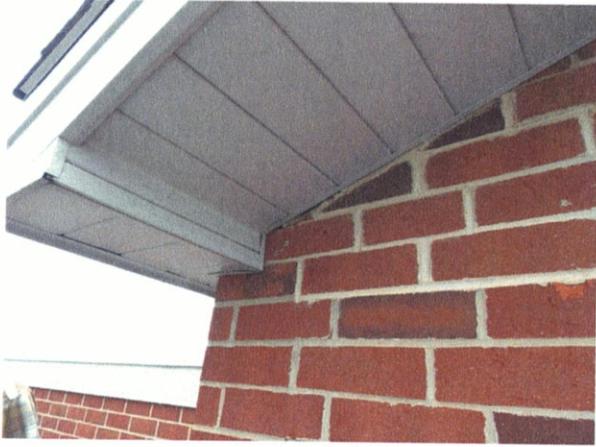
MTO C was located at the southwest corner of Roof D above Roof E. A crack had developed on the southern face of adjoining this corner.

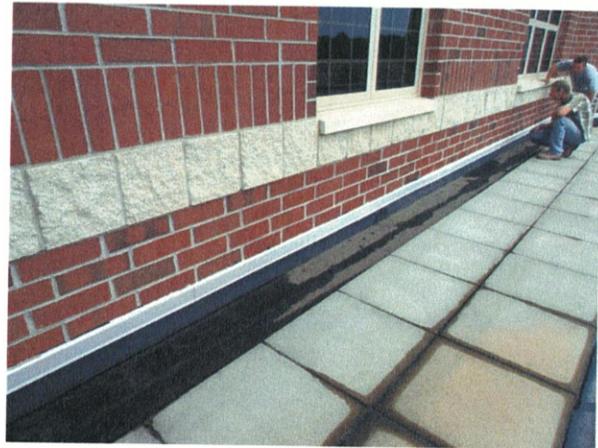
Masonry Test Opening D

At this location, over the Middle School Office Nurses Station, a water test was performed first at the northern end of the roof area. Water was first applied to the roof and flashing with no moisture entry.

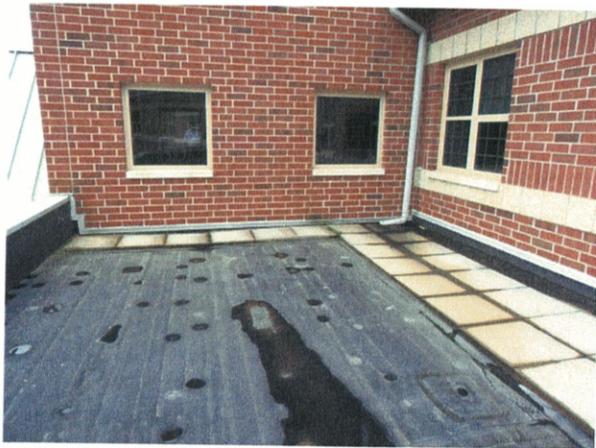
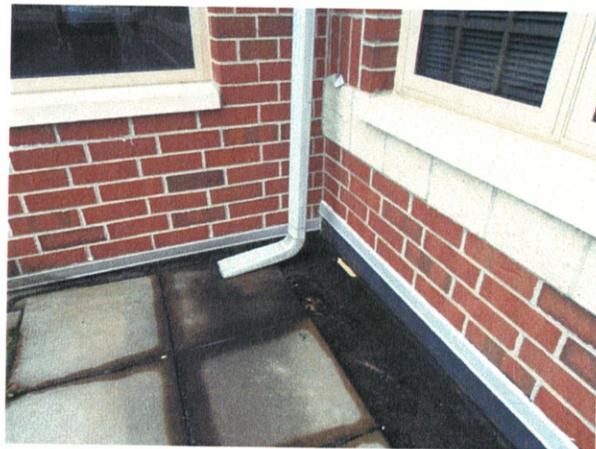
Masonry Test Opening E

MTO E was located above the Middle School Main Office storage room. A water test was also performed in this area. Moisture eventually entered after the wall became saturated. A test opening was created below the first window north of the skylight.

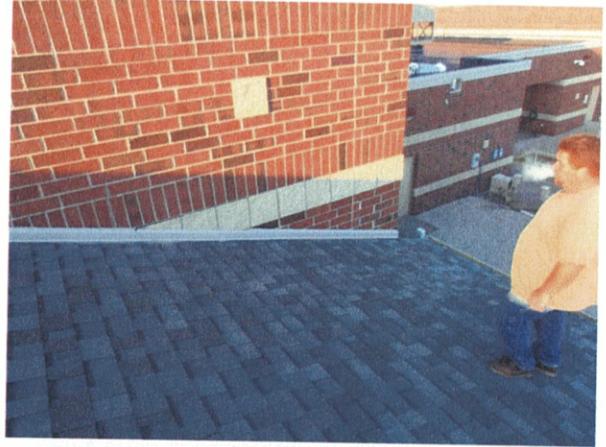
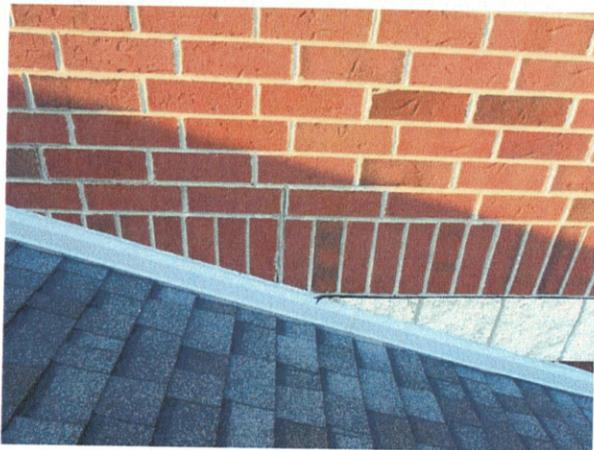
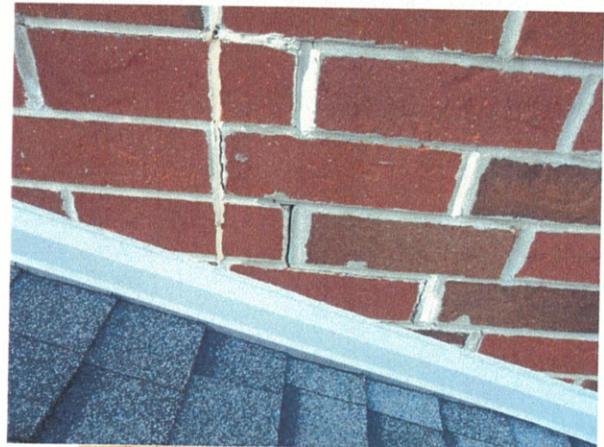
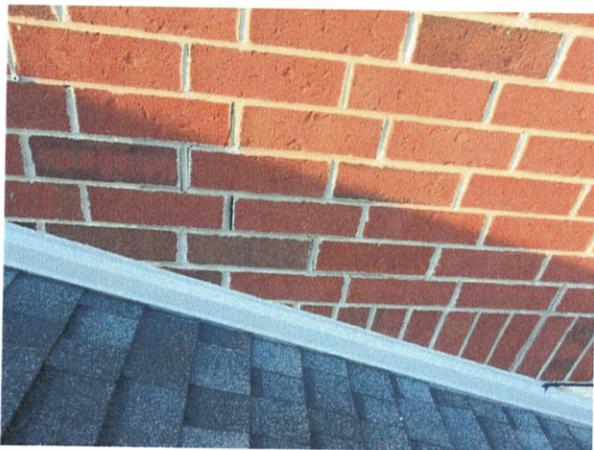
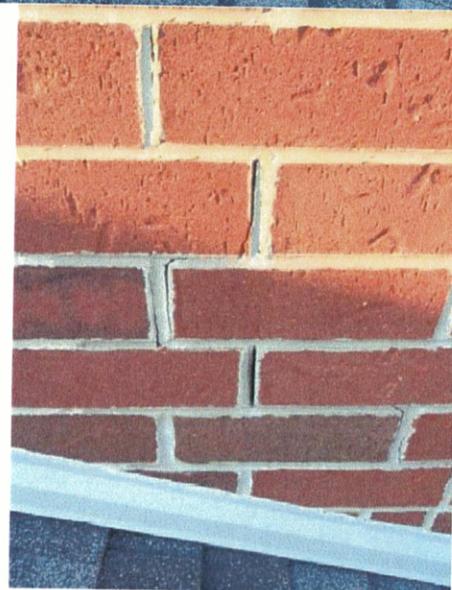
Wall above Roof C

On July 21, 2011, an additional site visit was made to view the conditions of Roof C and the adjoining masonry wall components above Roof C. Numerous step cracks are present directly above the through wall flashing in the masonry.

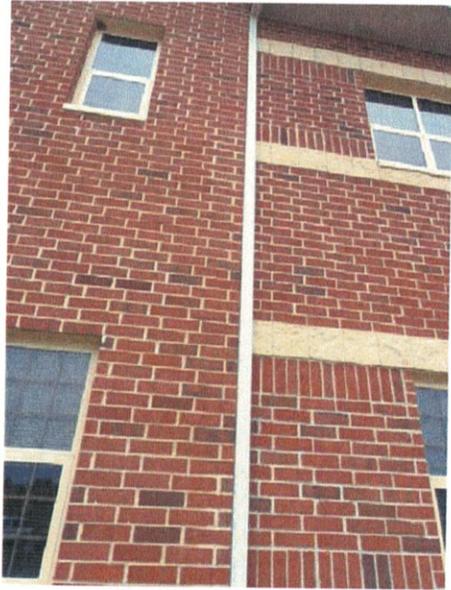
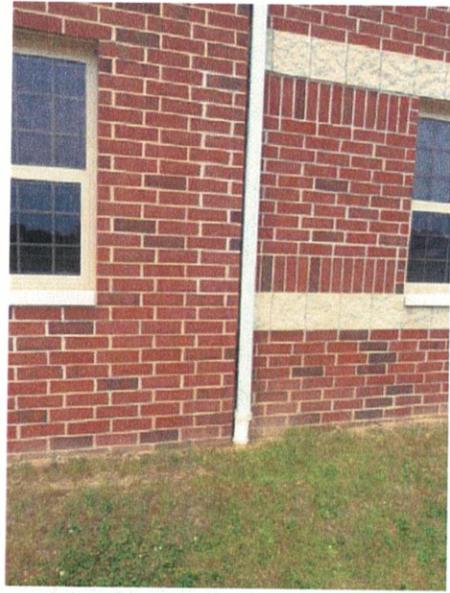
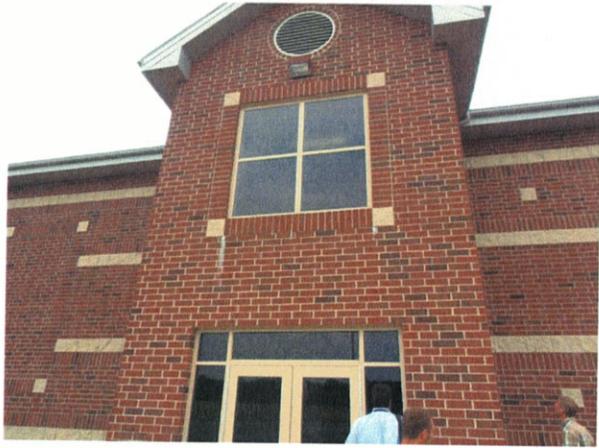
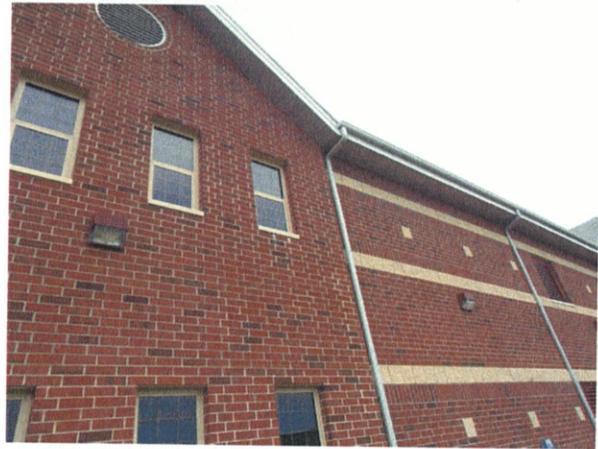
Control Joints and Vertical Cracks

When the perimeter of the building was viewed, numerous vertical cracks were present, especially at the masonry present below the dormers on the east side of the building. The presence of these cracks implies that this building needs additional capacity to absorb movement. These cracks will continue to deteriorate and further masonry deterioration may develop if this situation is not further investigated and properly resolved.
