**IN THE COURT OF CLAIMS
FOR THE STATE OF OHIO**

WILLIAM ANDREW CAMPBELL	:	CASE NO. 2013-00502
	:	Judge Patrick M. McGrath
Plaintiff	:	Magistrate Anderson M. Renick
vs.	:	PLAINTIFF'S RESPONSE TO
	:	DEFENDANT'S MOTION FOR
THE OHIO DEPARTMENT OF	:	SUMMARY JUDGMENT
NATURAL RESOURCES	:	
	:	
Defendant	:	Oral Argument Requested
	:

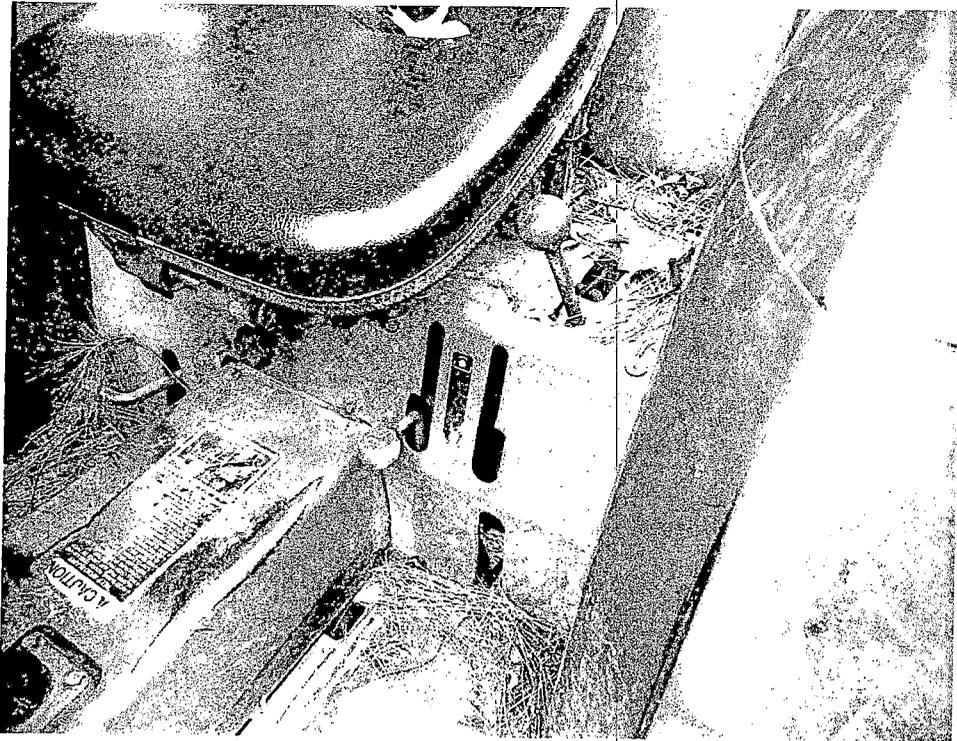
PTO shaft was engaged with the tractor's engine running without the operator in the seat, then the engine would stop. It was noted that at the time of the incident, the seat switch had been bypassed which disabled the operator presence system.

Photograph #3. View of the PTO lever located beneath the operator's seat. [Reproduced from photographs taken by Patrick Brown]

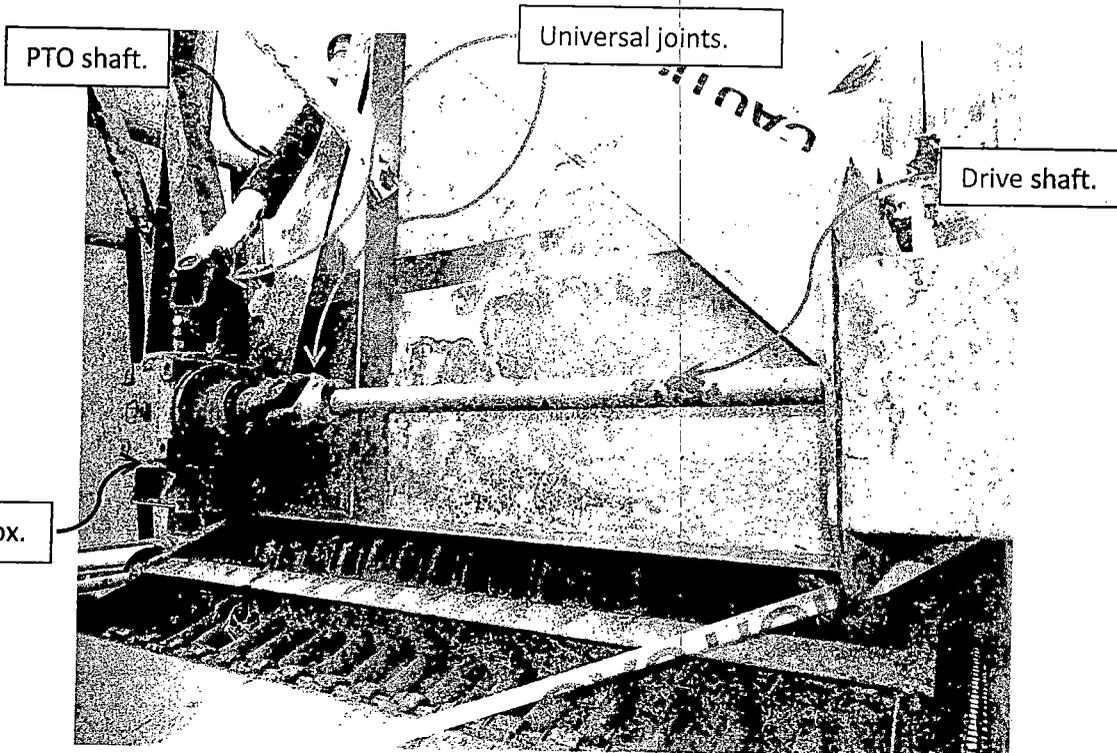
It was also noted that two other barrier guards were not present at the time of the incident. One was the shield that covered the universal joint on the machine (aft) end of the PTO shaft that was connected to the gear box. The other missing guard covered the sprocket and chain that supplied mechanical power to the seeder attachment.

Photograph #9. Top view of 548 Aero-Blade. Note right-angle gear box, universal joints, drive shaft, and PTO shaft. [Reproduced from photographs taken by Patrick Brown]

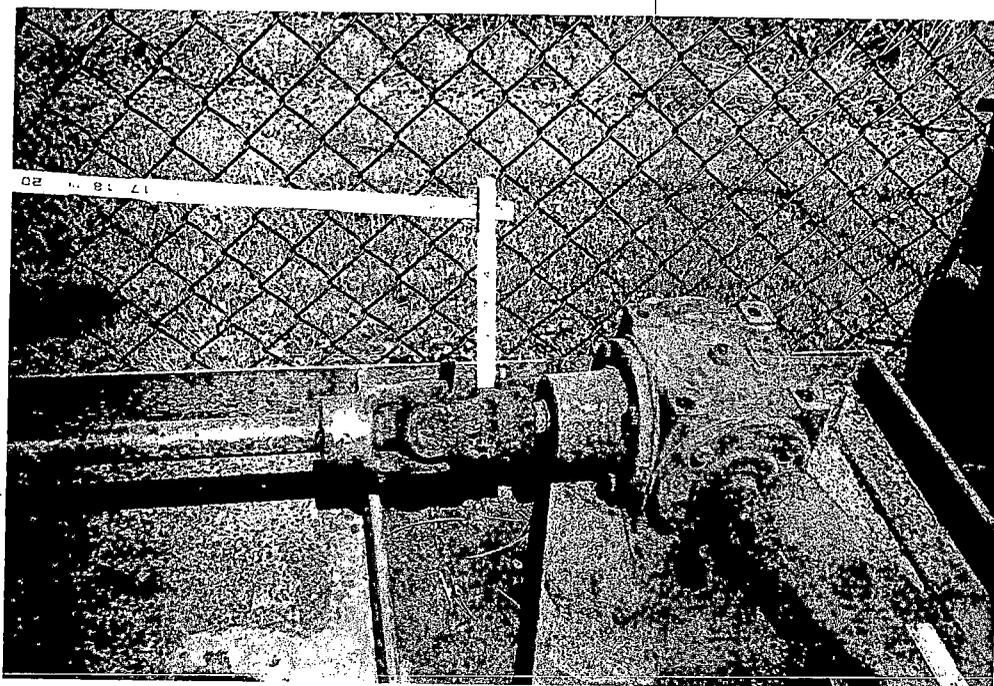
As noted earlier, if the barrier guard over the right angle gear box had been in place, Mr. Campbell's left sleeve would not have been caught by a protruding bolt on the rotating universal joint and this incident would have been avoided in its entirety.

Photograph #10. View of right-angle gear box, universal joint, and horizontal shaft. Note the bolt protrudes about 0.70 inches.

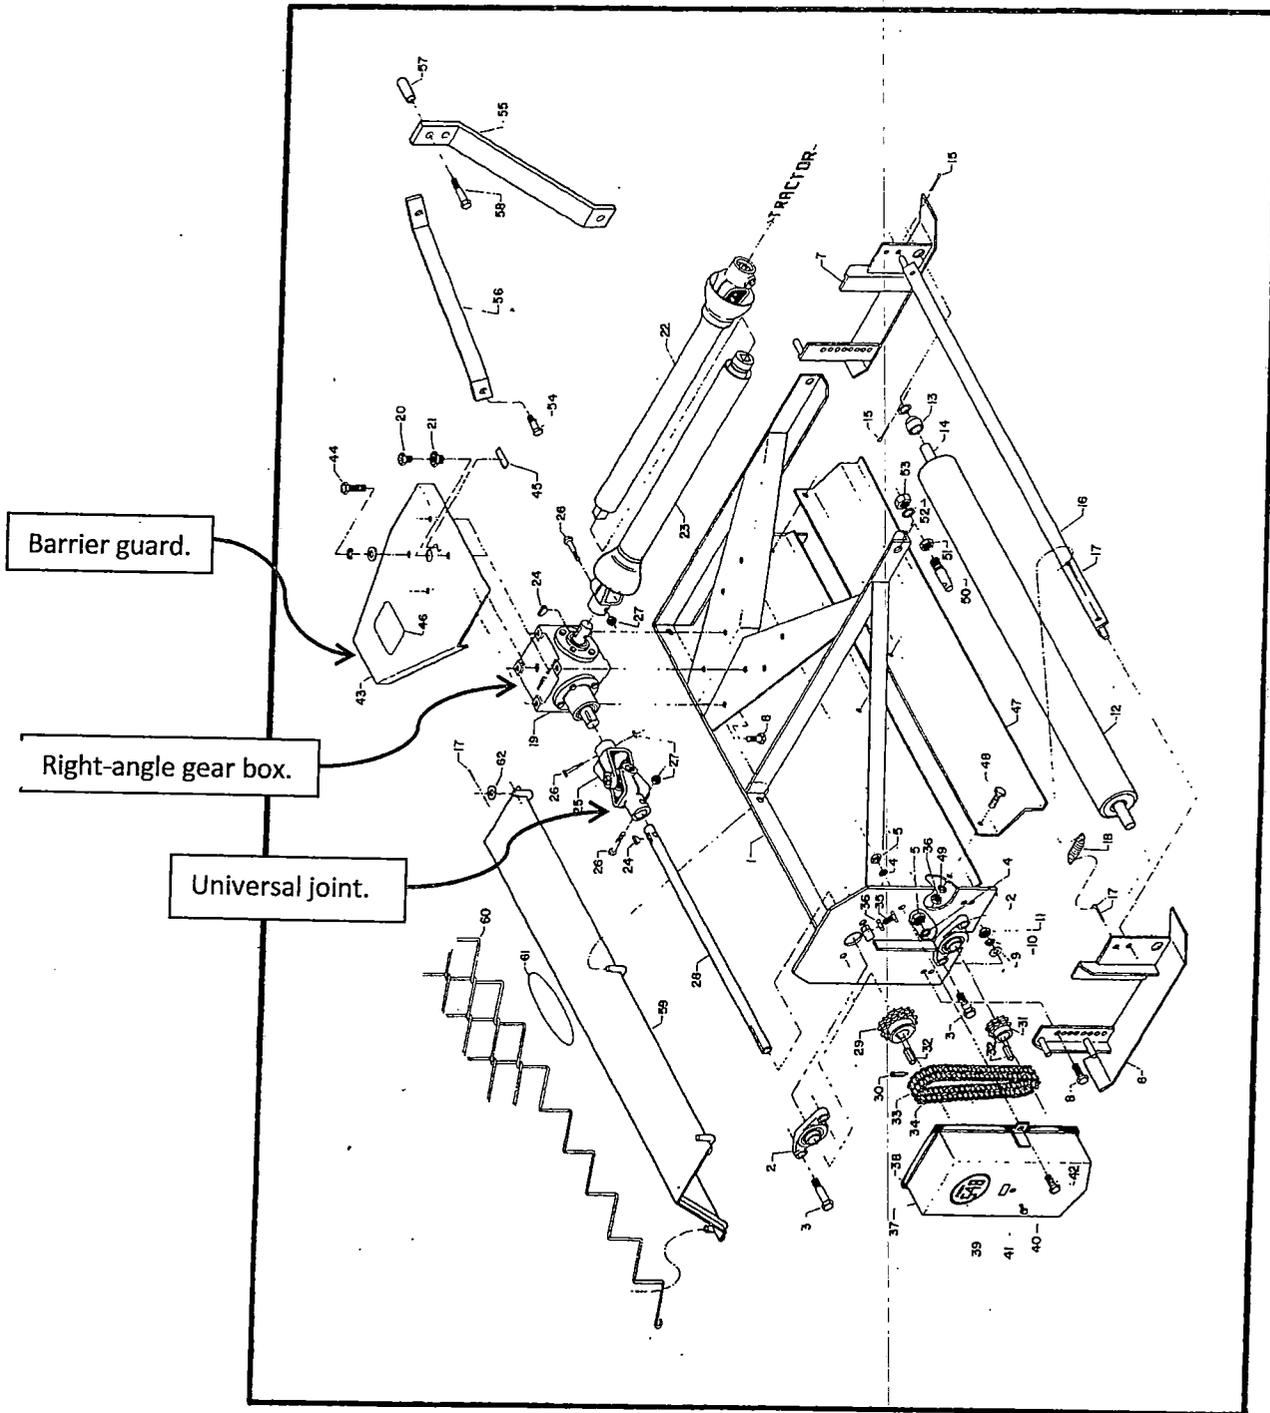
**PROD. NO. 82548
MAIN FRAME ASSEMBLY**

In addition, it is this investigator's opinion that on August 29, 2011, the model 548 Aero-Blade aerator and the model 1070 tractor used at the Shawnee State Park golf course were in an unnecessarily dangerous configuration because the inherent, recognized, mechanical hazards associated with the PTO method of transmitting power were not effectively controlled. In brief, the rotating universal joint connected to the drive shaft at the right-angle gear box was not guarded to protect against employee contact.

Figure #1. Exploded view of parts from 548 Aero-Blade Owner's Manual. Note barrier guard over right-angle gear box.
