DARLENE LANE FERRARO,)	CASE NO. 2011-10371
)	
Plaintiff,)	JUDGE PATRICK McGARTH
)	
vs.)	<u>PLAINTIFF'S RESPONSE TO</u>
)	<u>DEFENDANT'S MOTION FOR</u>
THE OHIO STATE UNIVERSITY)	<u>LEAVE TO DEPOSE PLAINTIFF'S</u>
MEDICAL CENTER)	<u>EXPERT</u>
)	
Defendant.)

RE: Junior Lane (deceased)
Our File Number: 09-198

Preliminary Reconstruction Report

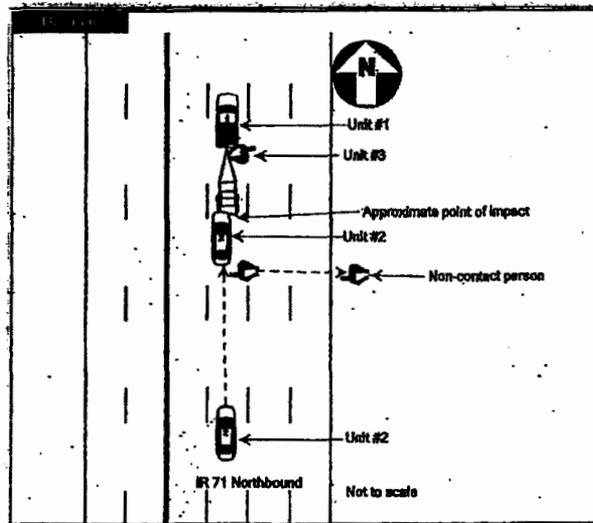
Police diagram of crash

UNIT #1 (A PICKUP TRUCK PULLING A TOW DOLLY TRAILER) WAS TRAVELING NORTHBOUND ON IR-71 WHEN THE DRIVER STOPPED TO ADJUST THE TRAILER. AFTER STOPPING, TWO OF THE ORIGINAL OCCUPANTS OF UNIT ONE, JUNIOR LANE AND JESSE FURY (LANE MARKED ON DIAGRAM AS UNIT #3 AND FURY MARKED ON DIAGRAM AS NON-CONTACT PERSON) EXITED THE VEHICLE TO REPAIR/ADJUST THE TRAILER. UNIT #3 BEGAN TO WORK ON THE TRAILER HITCH AND WAS POSITIONED BETWEEN THE TRAILER AND THE REAR OF THE PICKUP. THE NON-CONTACT PERSON WAS POSITIONED IN THE ROADWAY APPROXIMATELY 10 FEET BEHIND THE TRAILER, WAVING A WHITE T-SHIRT IN AN ATTEMPT TO WARN ONCOMING MOTORISTS OF THE STOPPED VEHICLE. UNIT #2, TRAVELING NORTHBOUND ON IR 71, DID NOT SEE UNIT #1, UNIT #3, OR UNIT #4, AND SUBSEQUENTLY STRUCK UNIT #1 AND THEN #3. THE NON-CONTACT PERSON AVOIDED BEING STRUCK BY TAKING EVASIVE ACTION AND RUNNING OFF TO THE RIGHT SIDE OF THE ROADWAY.

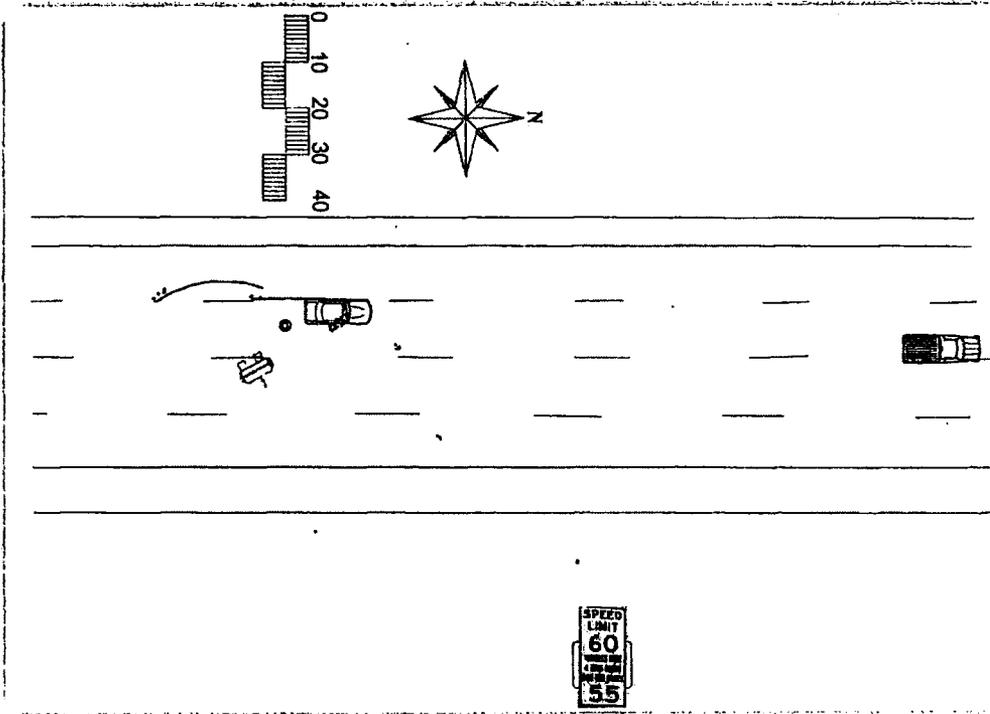
After crash situation drawings

Roadway Evidence. The investigating officer documented physical evidence including the final rest locations of the vehicles and the roadway geometry by forensic total station measurements and photographs.

Diagram. The working scale diagrams below shows the area of the crash, including the documented roadway evidence.

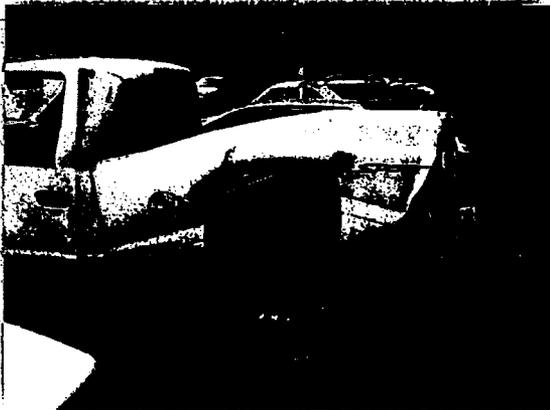
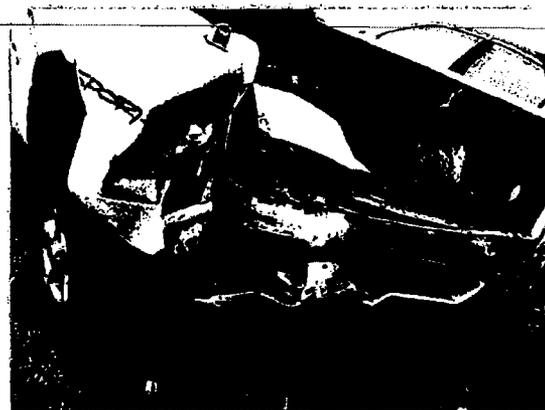
Police photos of damaged pickup

Pickup. The photos of the pickup showed evidence of contact to the rear on the left (driver's) side. The bed was crushed and collapsed forward against the cab of the truck where there was induced damage and intrusion into the occupant compartment.

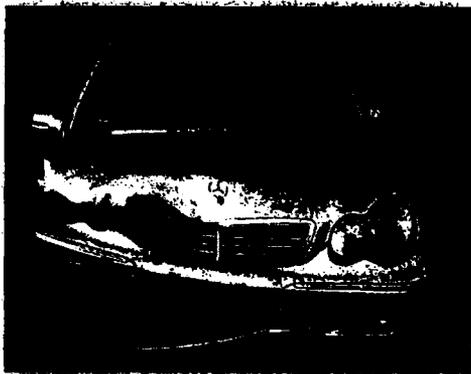
Police photos of damaged Mercedes

Mercedes. The Mercedes showed evidence of contact with the dolly about $\frac{3}{4}$ of the way across the right (passenger's) side of the front bumper. There was evidence of contact with the rear of the pickup almost half way across the right side of the front of the vehicle with a portion of the pickup's tail light assembly lodged in the Mercedes' grille.
