IN THE COURT OF CLAIMS OF OHIO

AFFIDAVIT OF ERIC MOSER

Re: Grand Valley Local Schools Roof Study

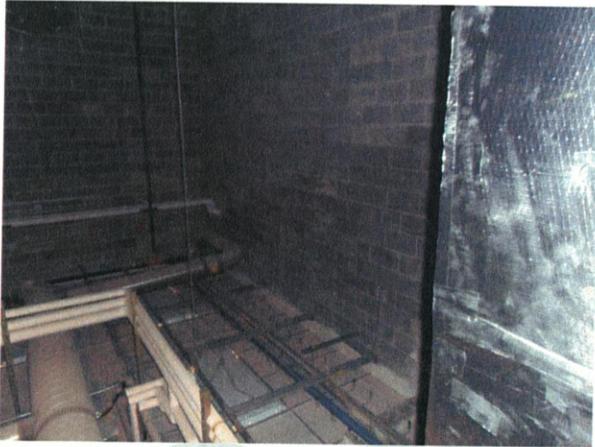
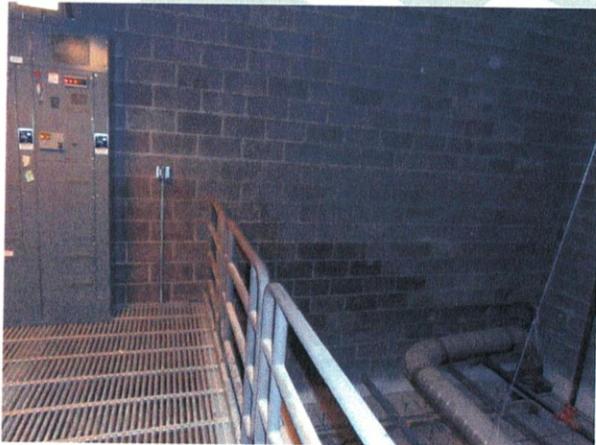
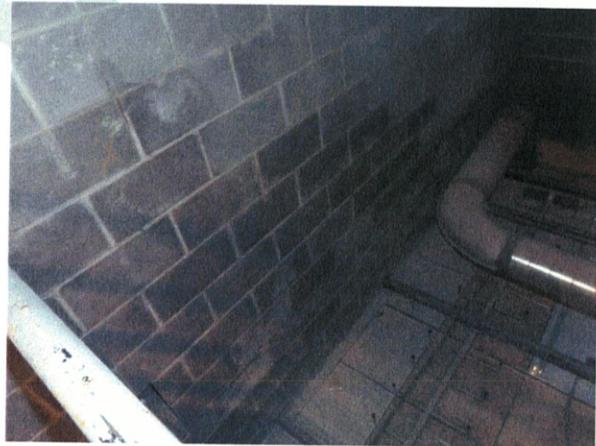
Wall below Roof B and above Roof C –

Note that this moisture entry follows the roof line of Roof C where open mortar joints were observed.

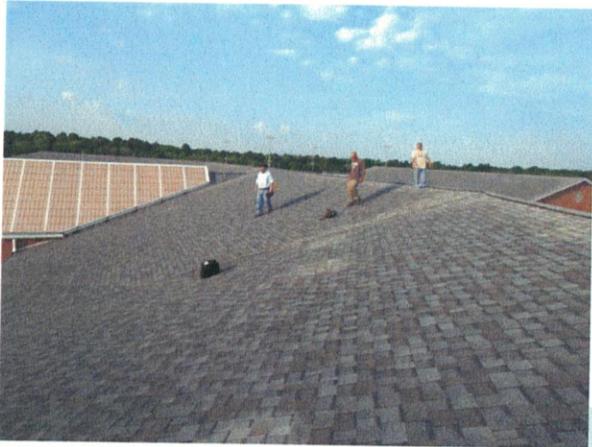
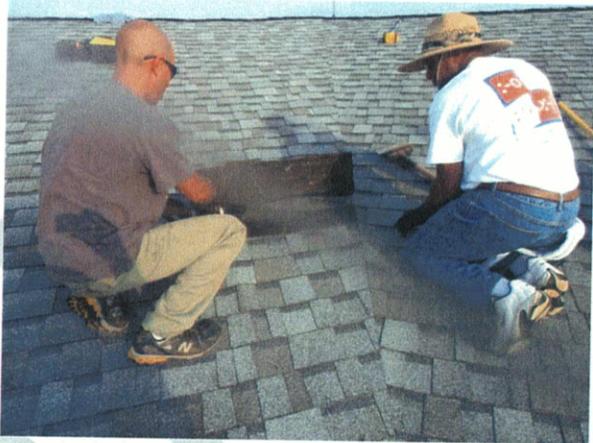
Roof Test Opening #1

RTO #1 was located the east face of the eastern most building section, at the closed valley north of the skylight. This area was chosen to view the construction of the closed valley and also due to the deflection present in the surface of the shingles.

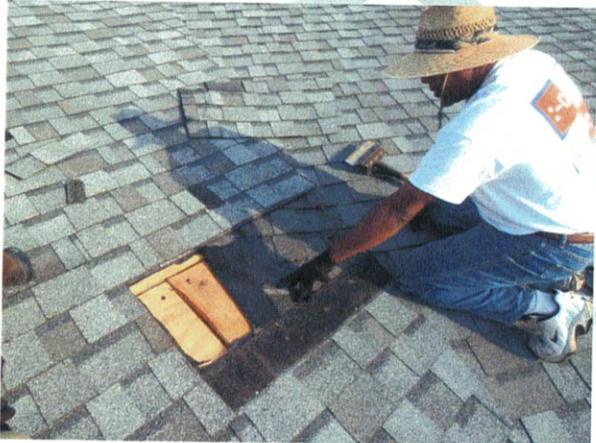
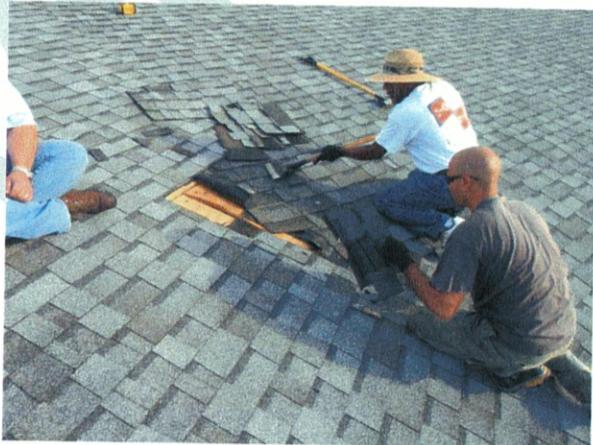
Once the shingles and underlayments were removed it was observed that the plywood of the vent board was curling and bowed.

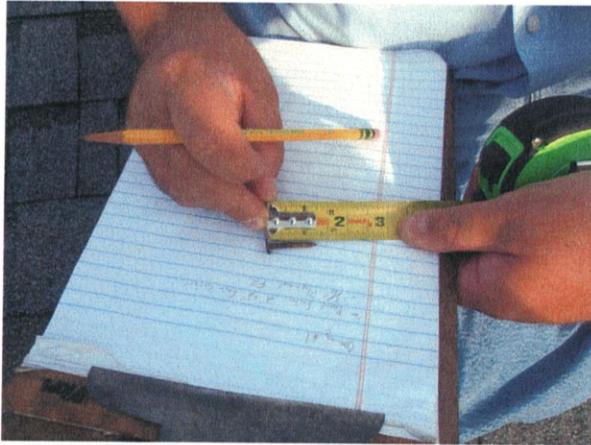
The nails used to secure the shingle at the site of the opening were measured to be 1.25" long and appeared to be chromium coated and rusting. Note that Ohio Building Code requires fasteners to be made of galvanized steel, stainless steel, or copper.

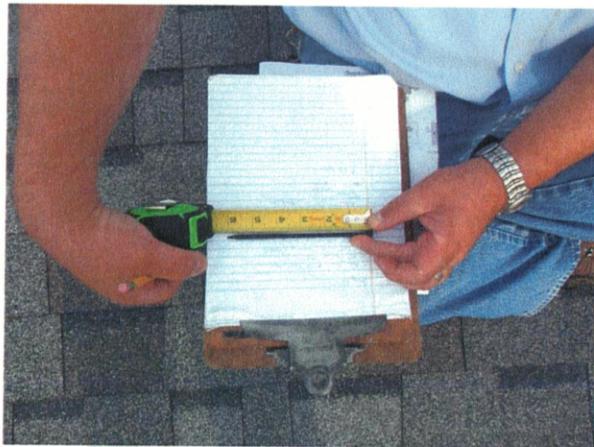
The fasteners used to secure the vent insulation board and underlying insulation were measured to be 6" long which was adequate to penetrate the upper rib of the steel deck

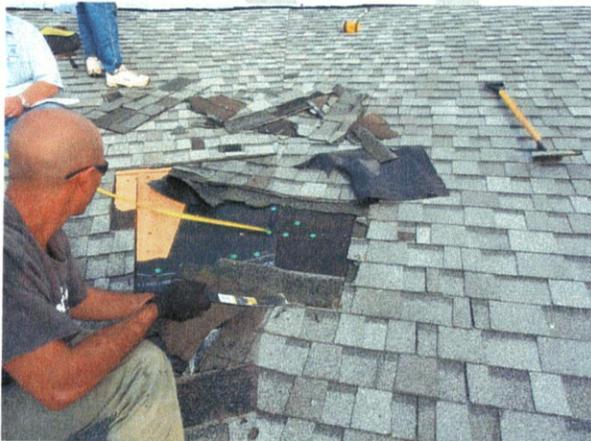
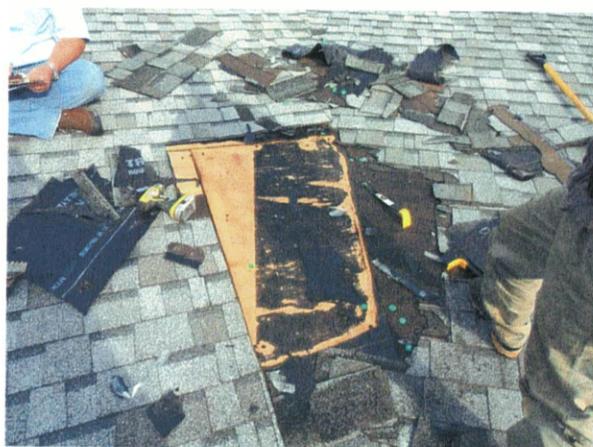
The shingles were then removed to expose the valley adjoining the area. Once the shingles were removed it was observed that a layer of bituthene was centered over the valley extending approximately 18" to either side of the valley. This condition meets Ohio Building Code requirements.

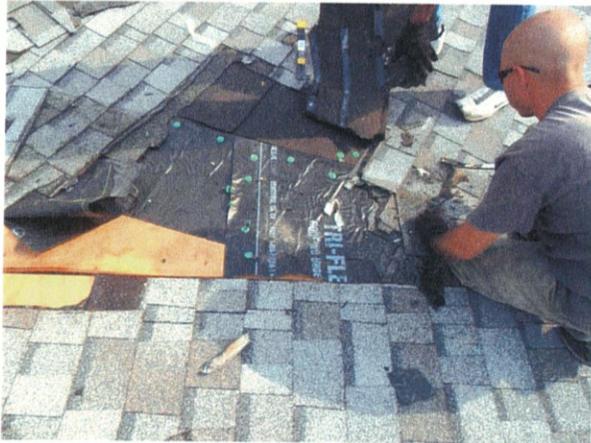
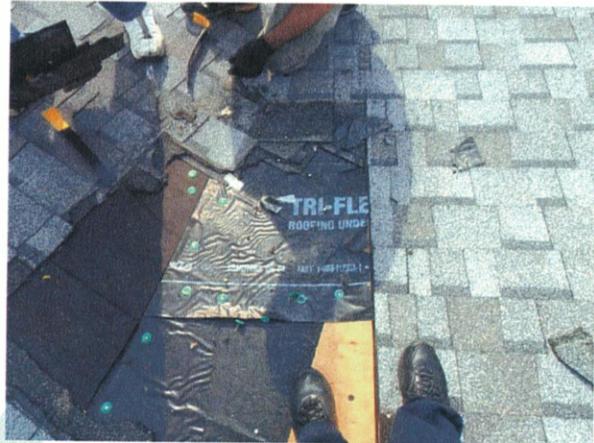
Over the plywood substrate, a combination of #30 felt and synthetic underlayment was present. The felt was observed to have been installed on the north side of the valley and the synthetic underlayment was present on the south side. The synthetic underlayment was observed to be Tri-Flex 30 Roof Underlayment. Both underlayments were secured in place with plastic cap nails.

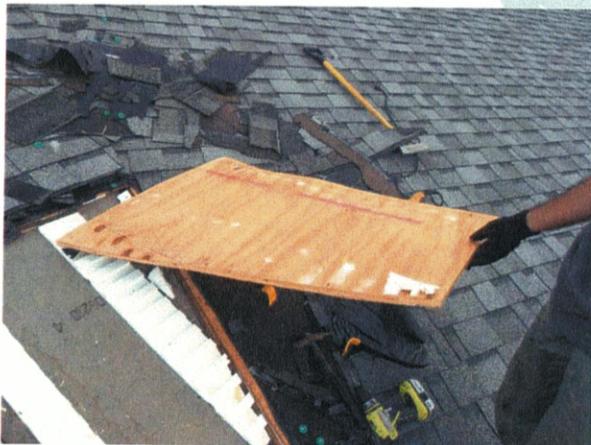
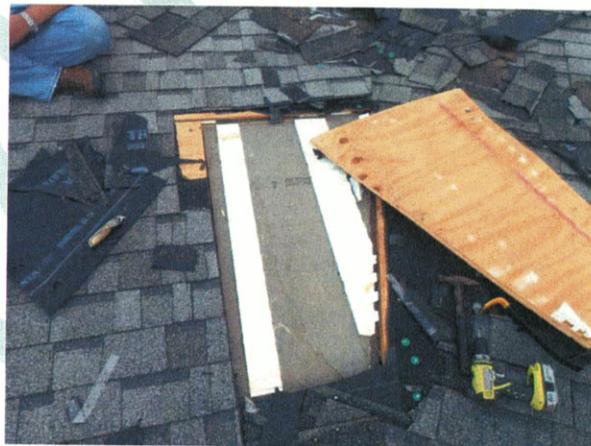
Once the underlayments were removed the fasteners were backed out of the plywood and it was observed to be no longer attached to the EPS blocking. Note that evidence of past moisture was present on the face of the polyisocyanurate insulation of the vent board.

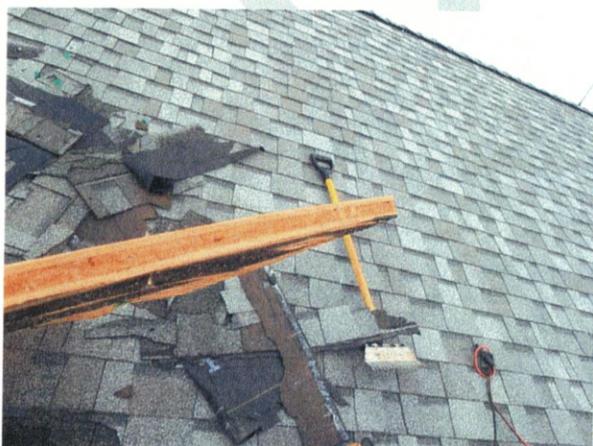
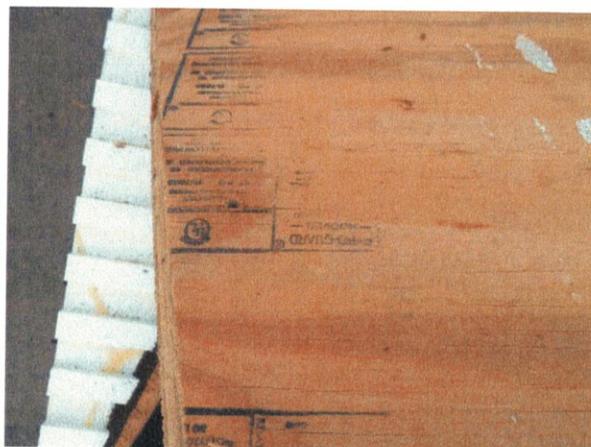
The removed plywood was viewed and it appears to be Hoover Pyro-Guard fire treated 3/4", 4-ply plywood.

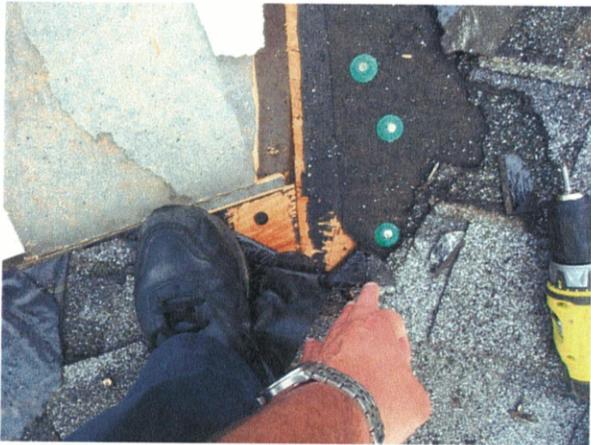
The plywood was observed to be tightly abutted at the valley. The Vent Board manufacturer requires a ¼” gap to be present between the plywood to allow for expansion. This does not appear to have been created and may be contributing to the deflection observed in the plywood substrate.

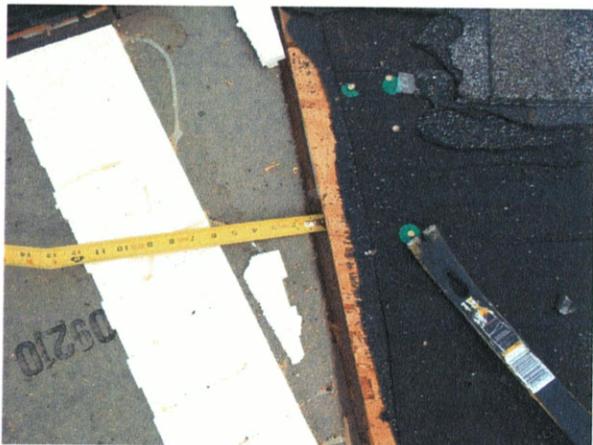
An approximate one gap was present in the valley between insulation boards creating a point of excess heat loss. In this system, the insulation board is meant to be tightly abutted in all details to create a complete insulation system. This gap in the insulation board could be contributing to the formation of ice damming.

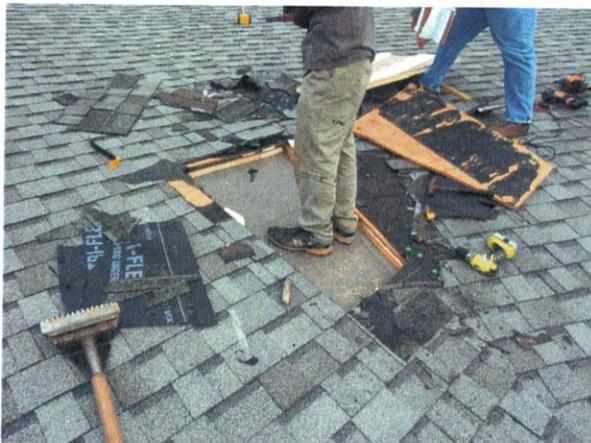
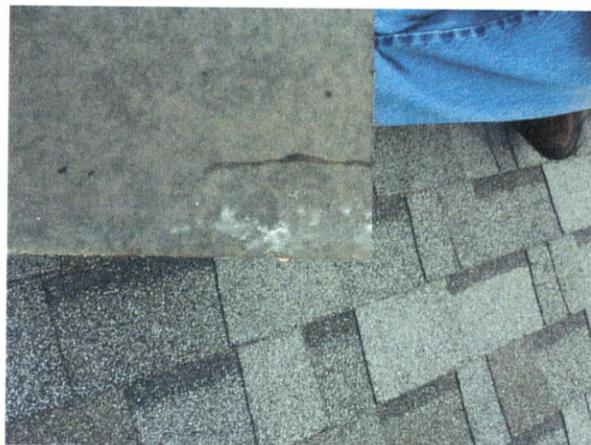
Once the polyisocyanurate board portion of the vent board was removed it was observed that an apparent biological growth on the facers of insulation.

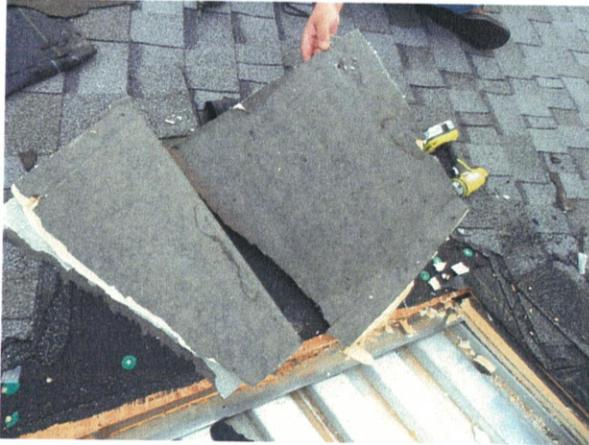
Past moisture stains were also observed on the underside of the bottom layer of insulation.

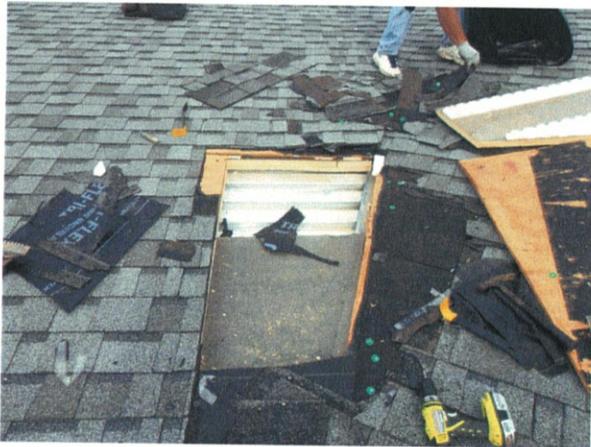
The bottom layer of insulation was removed and it observed that there was evidence of past moisture present in the low ribs of the deck.

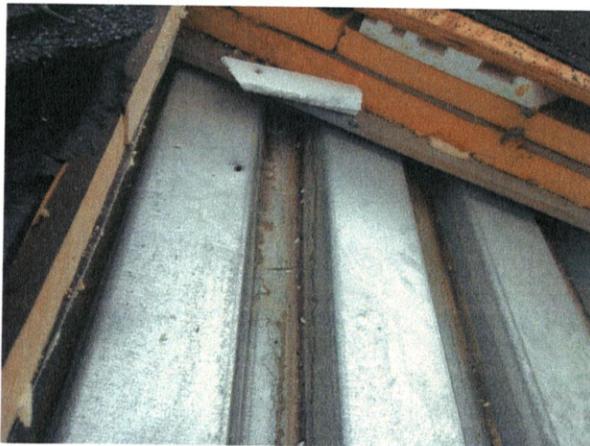
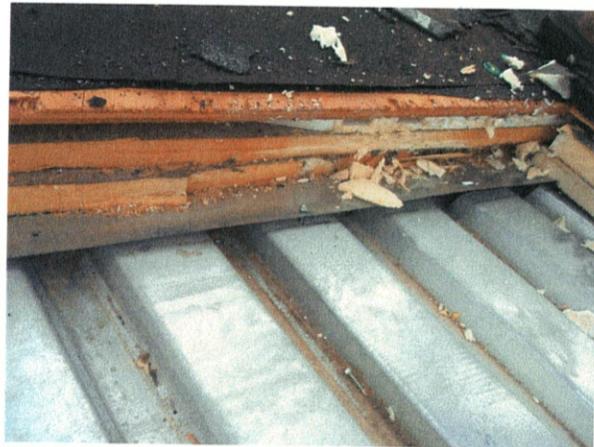
The fasteners securing the sheet metal valley between sections of deck had pulled out and were displaced. This could be a sign that excessive movement is occurring. It is recommended that a Structural Engineer evaluate this Building and its roof system in relation to this apparent lack of expansion capability.

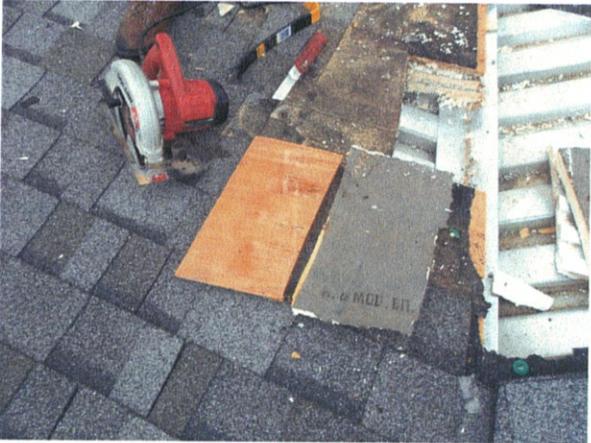
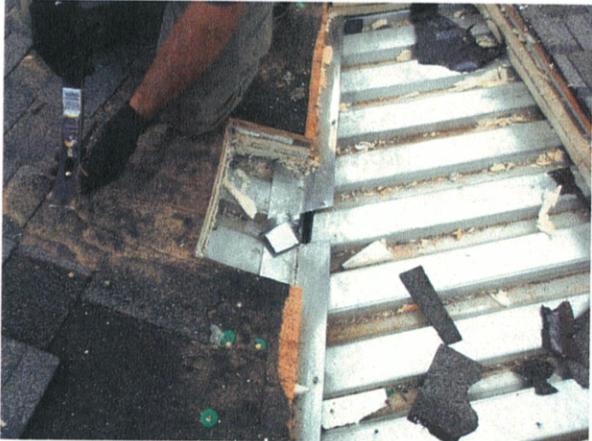
The valley closure was cut back on the north side of the valley. It was observed that there was a 1.5" gap between the decks on either side of the valley. In addition, a 3/4" gap was present between the trusses at the valley.

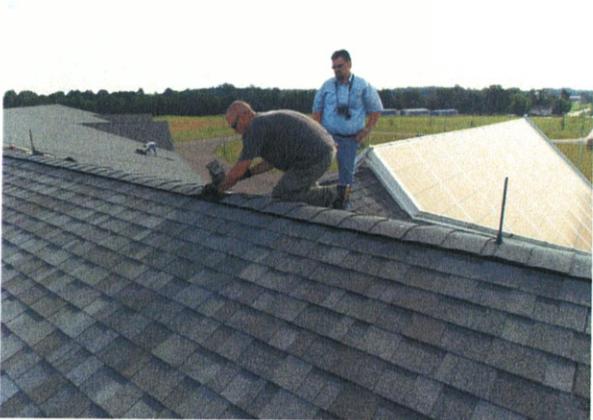
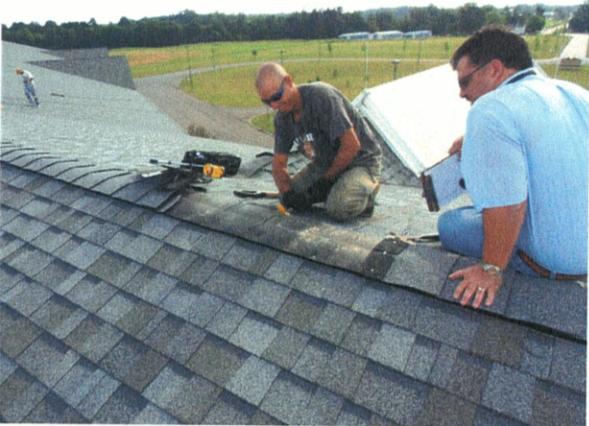
Roof Test Opening #2

At RTO #2, located on the north wing of eastern building, the ridge was opened. First the cap shingles were removed and then the ridge vent was removed.

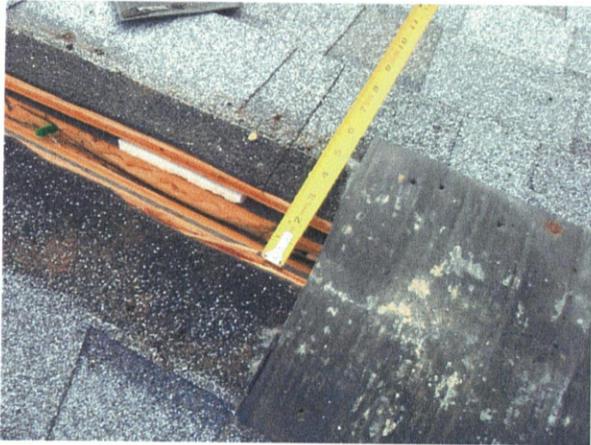
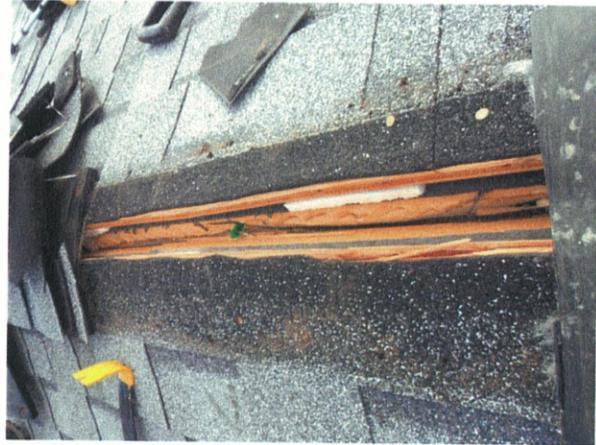
The opening present at the plywood of the vented R-board was approximately 2.5". It was noted that the insulation was not mitered at the ridge. Again, this reduction in insulation at the ridge is an improper installation and will contribute to heat loss.

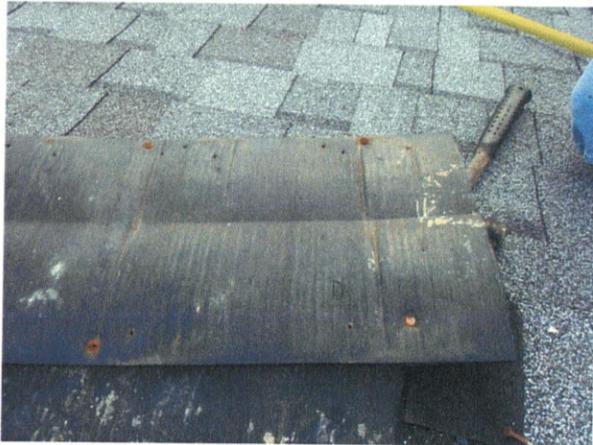
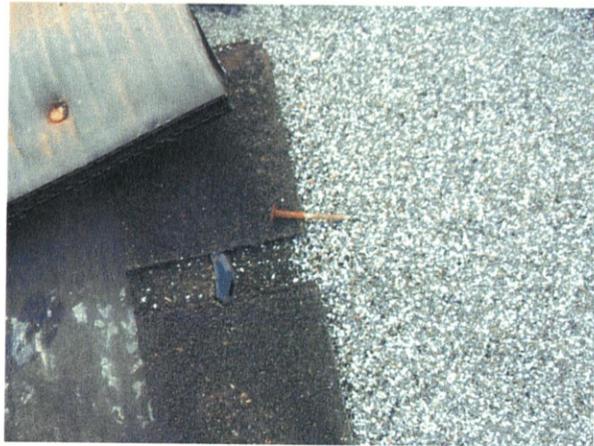
The ridge vent appears to have been originally secured with nails that measured approximately 1.25" long. These appear to be the same nails used to secure the shingles and are not long enough to secure the vent to the deck and penetrate a minimum $\frac{3}{4}$ ". Areas of replacement shingles were observed to have been secured with 2.5" nails.

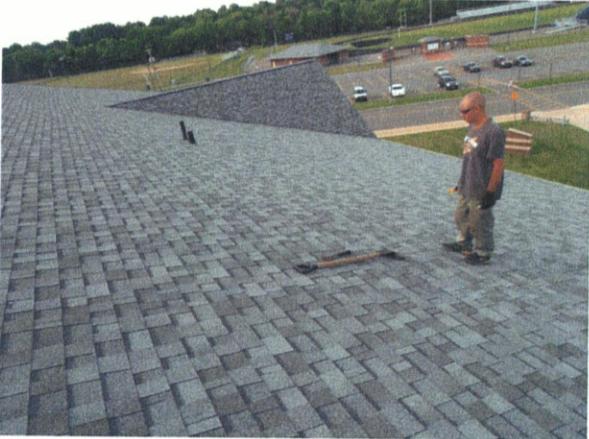
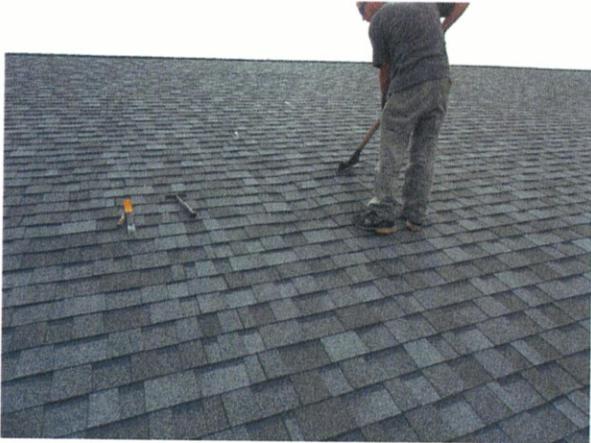
Roof Test Opening #3

RTO #3 was created on the west side on the southern wing of Roof A. The location was chosen due to the pronounce bowing present below the shingles.

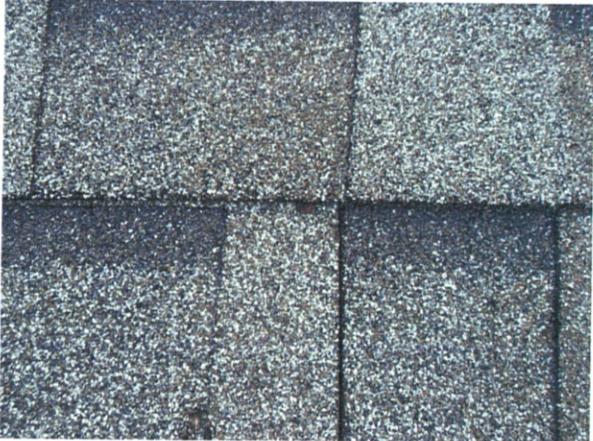
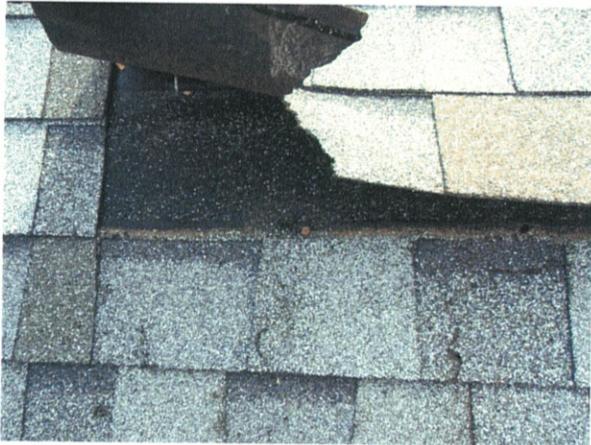
At the site of test area it was observed that nails securing the shingles were exposed in areas and that they were also rusted.

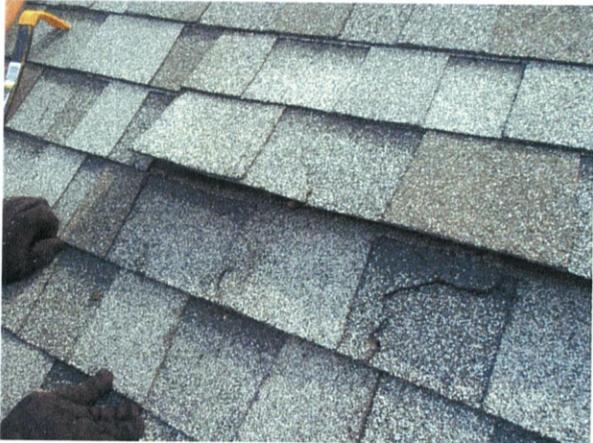
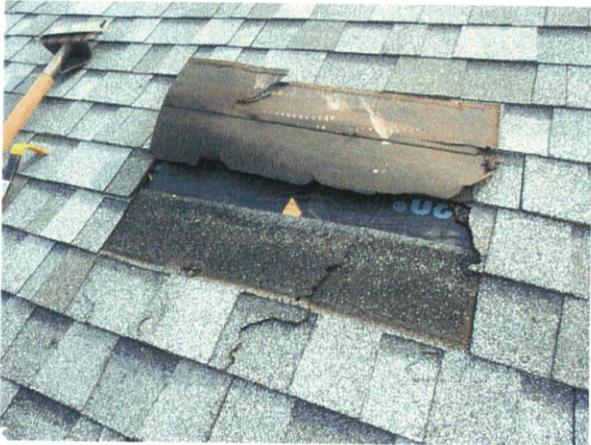
In addition, a shingle was observed to be torn at the test area, which may have been caused from the lack of expansion capability in the roof system.

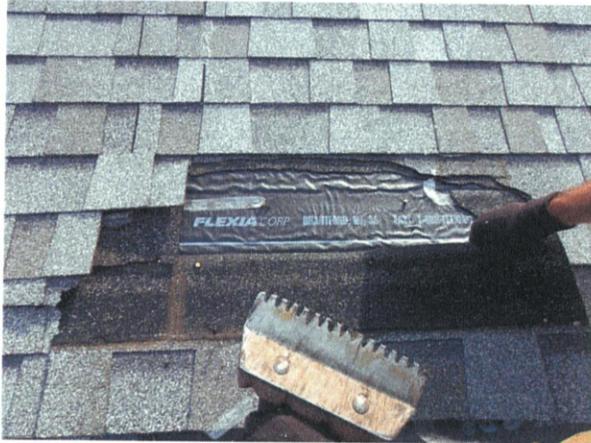
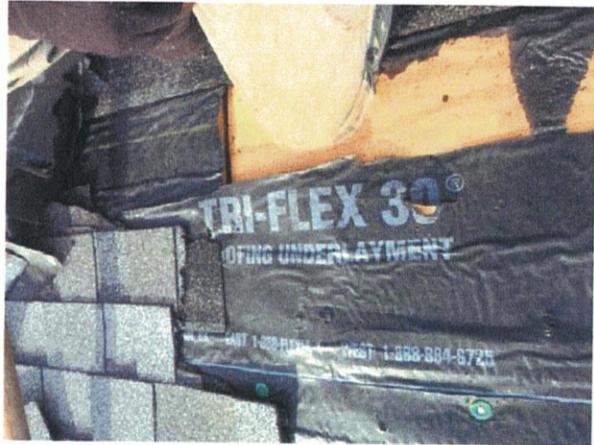
Once, the torn shingle and the underlying synthetic underlayment was removed the plywood was exposed. At this test opening the underlayment was the synthetic Tri-Flex 30 underlayment.

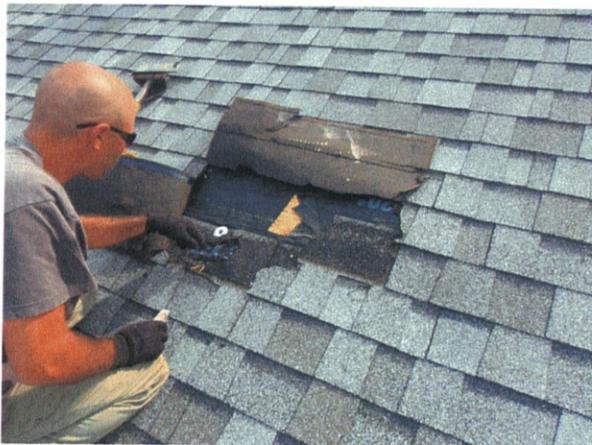
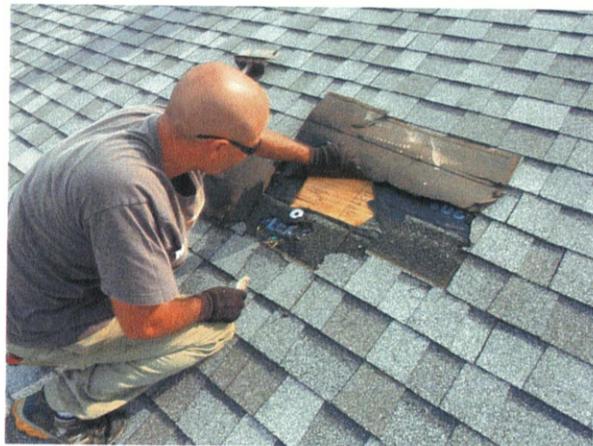
At this location the plywood was cracked and plates and fasteners were installed through the deck in an apparent attempt to flatten out the plywood. It is unknown when the fastener and plate was installed, since it was installed through an underlying shingle.

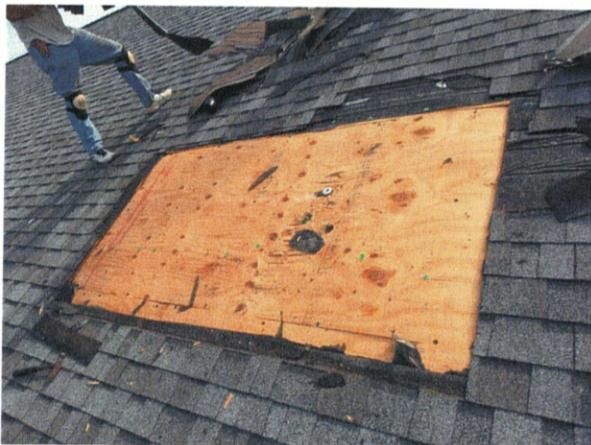
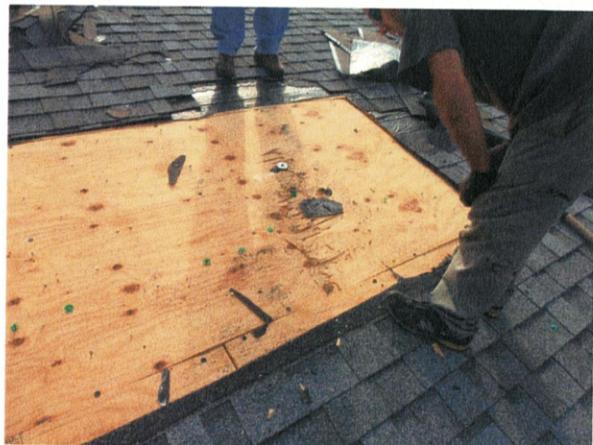
The shingles and underlayment were removed to expose a 4'x8' vent board that was installed with the 8' side of the board parallel with the gutter.

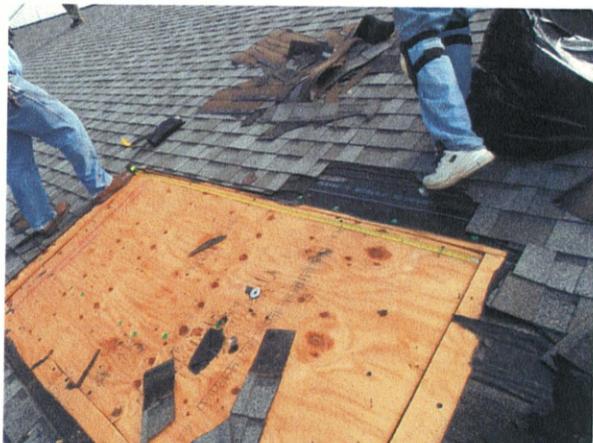
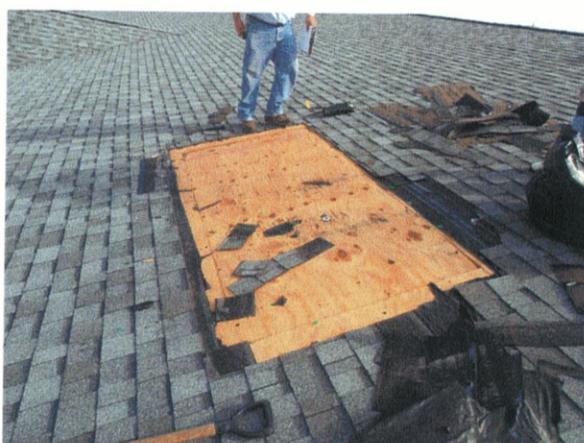
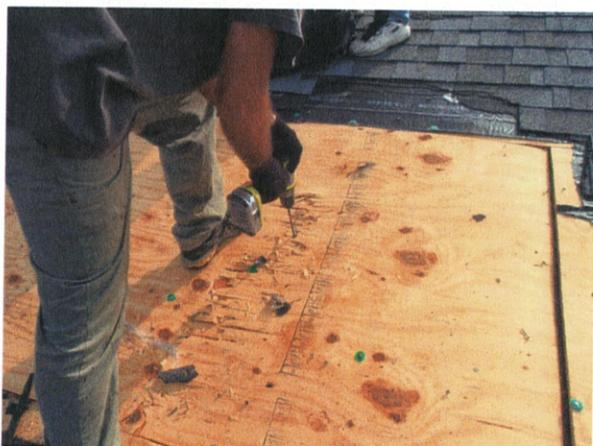
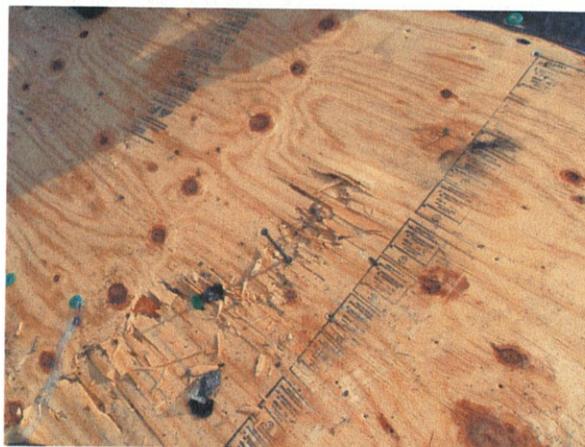
This board was secured with 18 fasteners. The fasteners were installed in 3 equal horizontal rows of 5 with 3 additional fasteners installed at the crack in the plywood. Based on the Manufacturer literature reviewed 15 fasteners would be adequate to secure the board.

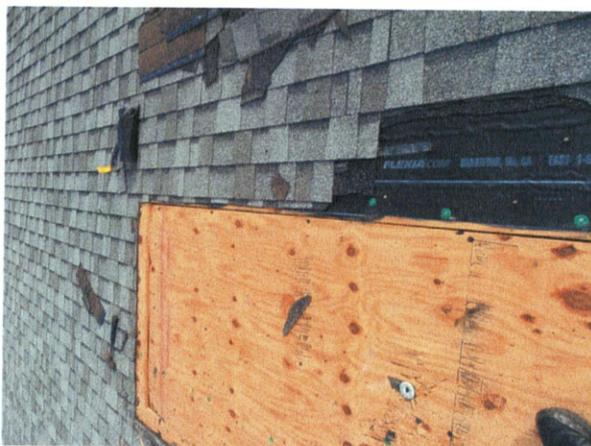
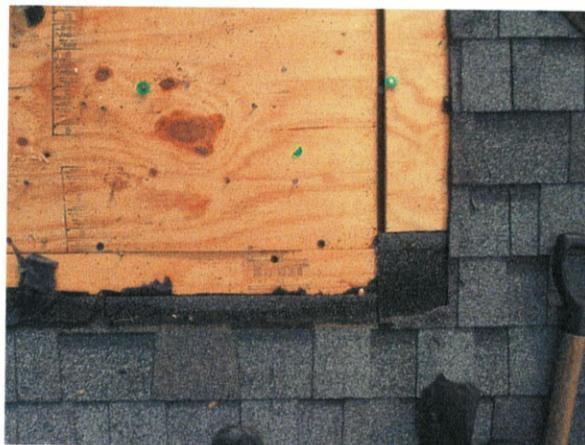
It was observed that a 1/4" gap was present along the top of the board and no gap was present along the bottom of the board. Approximately 1/8" to 1/4" gaps were present along the sides of the board, but these gaps appeared to be due to the warping of the board. A 1/8" gap should be consistent around the perimeter of the board based on the literature reviewed from Atlas.

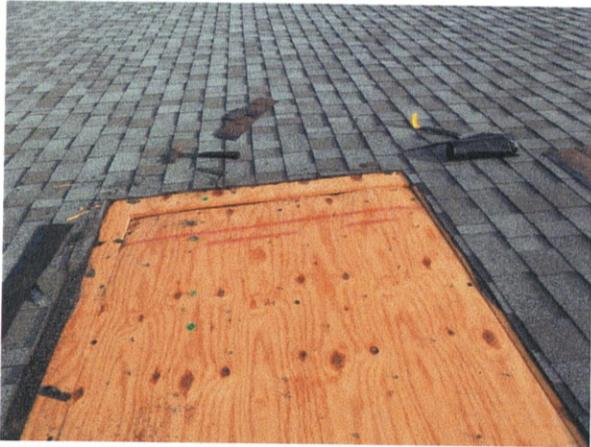
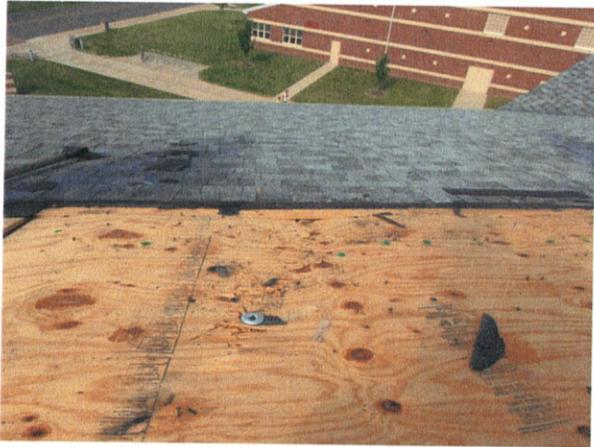
Once the fasteners were removed the plywood warp of the board was more pronounced.

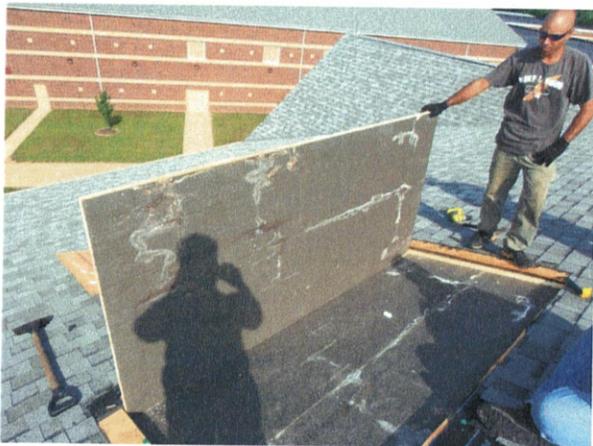
Significant staining was present on the facers between the vented board and the underlying 1.5" polyisocyanurate insulation board.

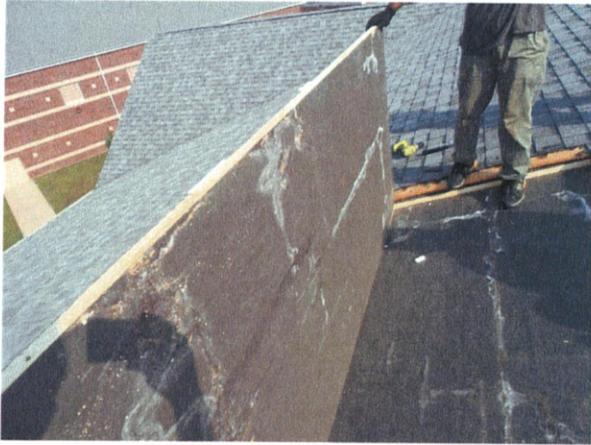
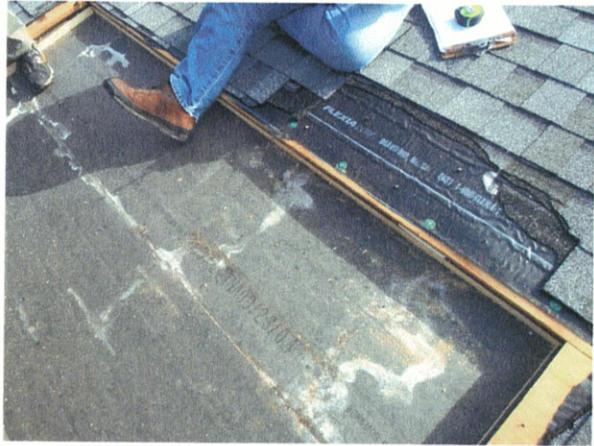
It was observed that the NTB fasteners were installed near the edge of the plywood and also installed at an angle. This appears to have been done to ensure that the fastener would catch the upper rib of the metal deck. This placement of the fasteners is not in accordance with the Manufacturer, who states that the perimeter fasteners should be placed 3" to 6" from the edge of the board. A diagram of proper placement has been included later in this report.

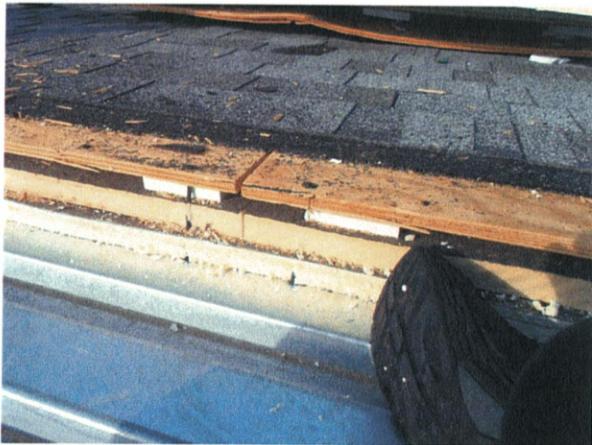
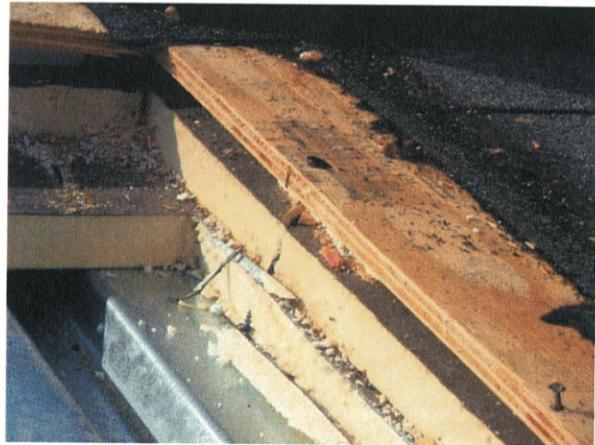
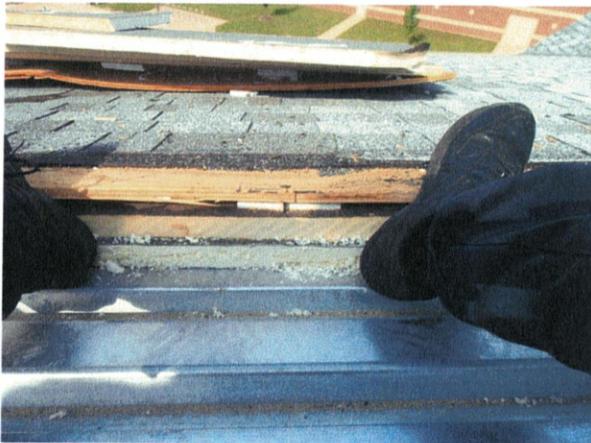
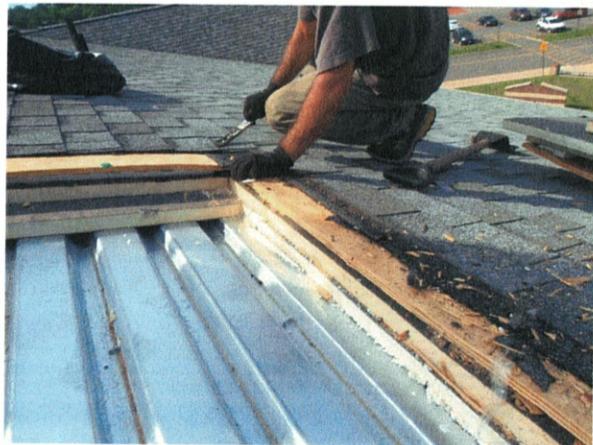
Minor surface rust was observed to be developing in the low ribs of the deck. This could have been present during construction of the building.

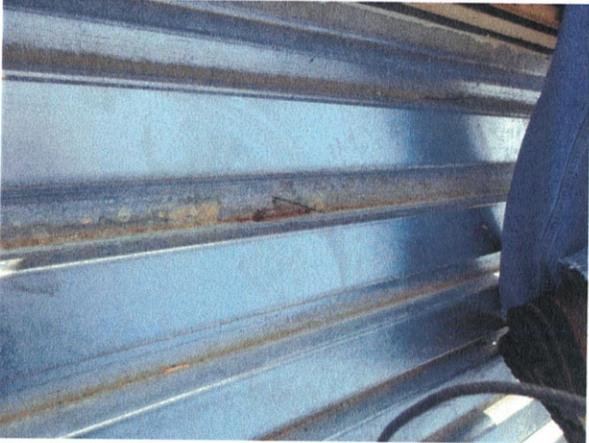
It was also observed that the fasteners used to secure the deck to the structure were backing out in areas, again possibly due to roof movement and the lack of expansion provision in the design of the roof system. This condition may be compromising the wind attachment of the roof assembly and deck. A Structural Engineer should investigate this condition and determine proper remediation.

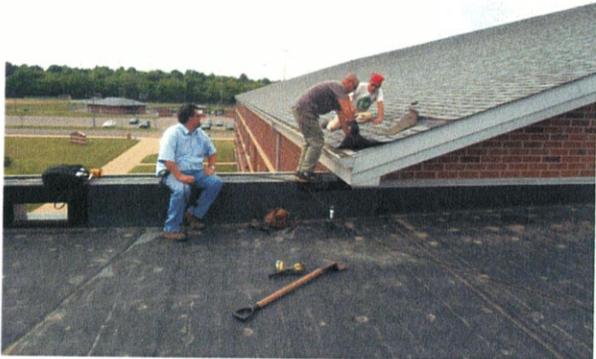
As the shingles were removed it was observed that while a starter shingle was installed up the rake, but no bituthene was present. In addition, the bituthene present at the gutter was installed to a distance 34" up from the gutter and 28" from the exterior face of the exterior wall. Ohio Building Code requires the underlayment to be installed a minimum of 24" inches from the interior of the exterior wall. This installation does not comply with this requirement.

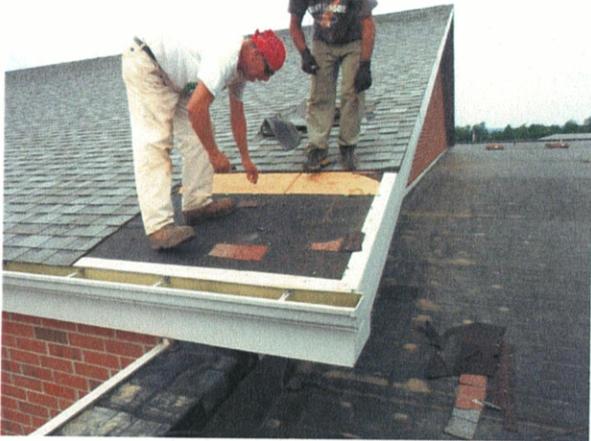
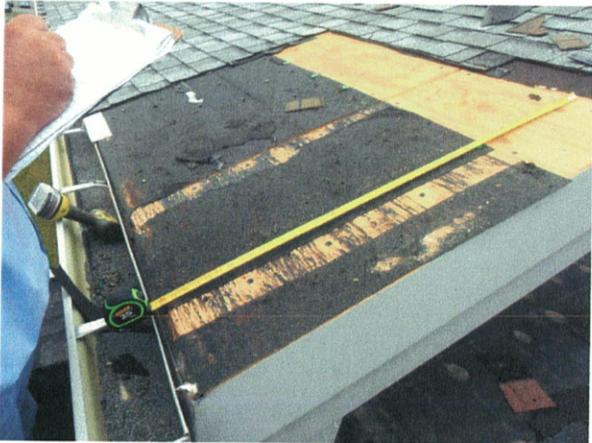
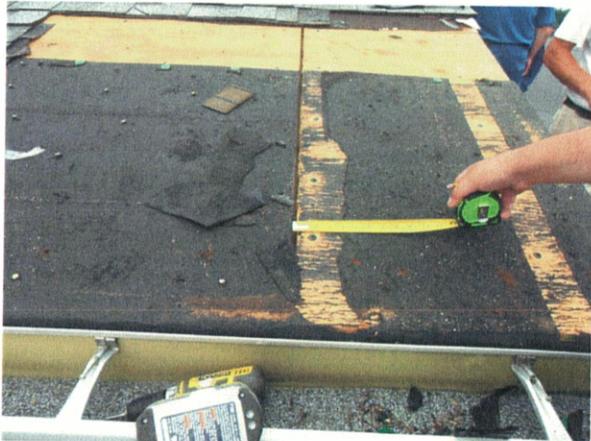
No signs of deterioration were observed on the plywood or the facers on the insulation.

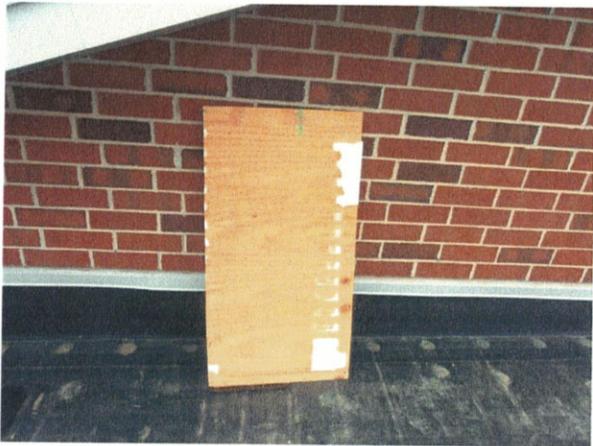
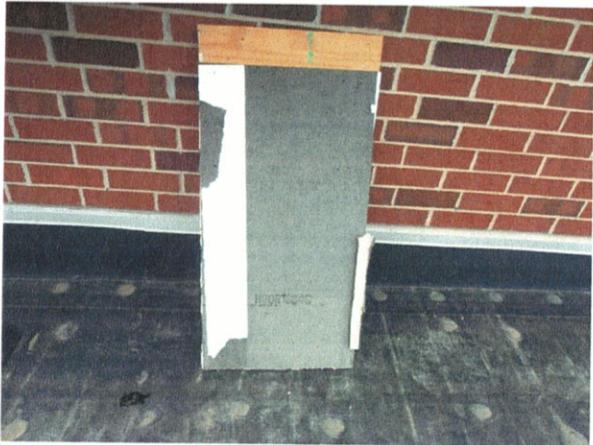
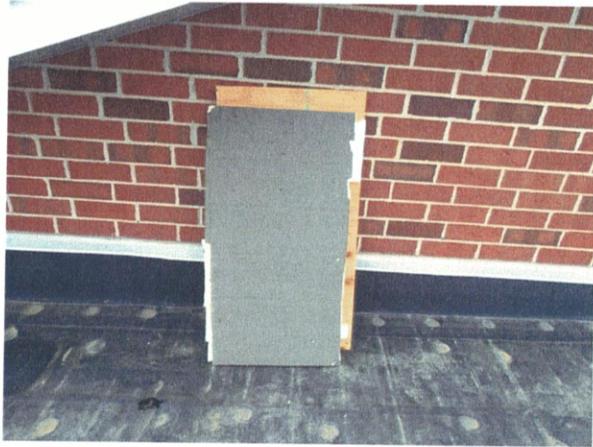
It was observed that the bottom layer of insulation was set back from the lumber at the gutter edge to allow for air movement; however, the insulation for the vent board was tightly abutted to the wood inhibiting air flow from the soffit into the air space of the vent board.

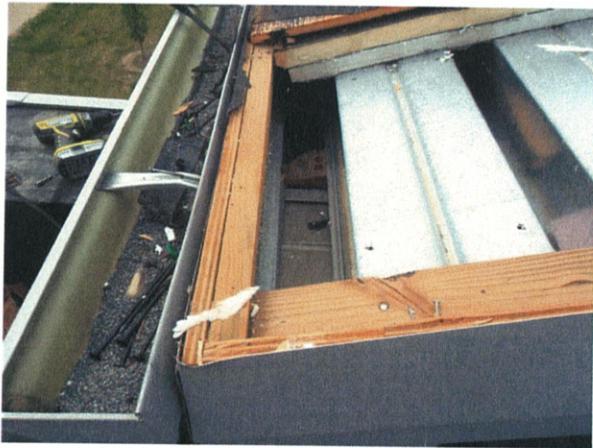
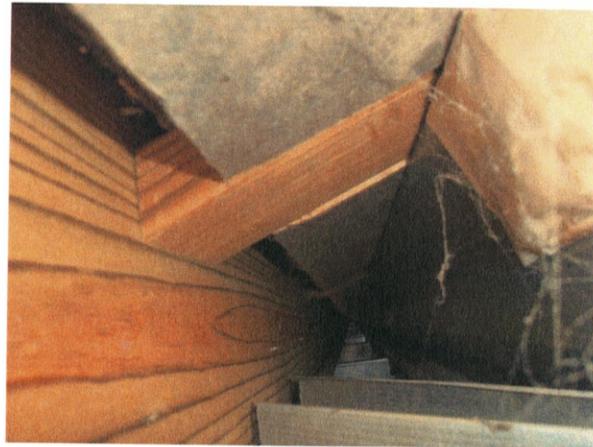
Roof Test Opening #6

RTO #6 was located near the center of the west face of Roof D. This area was chosen due to the displacement observed in the shingle surface.

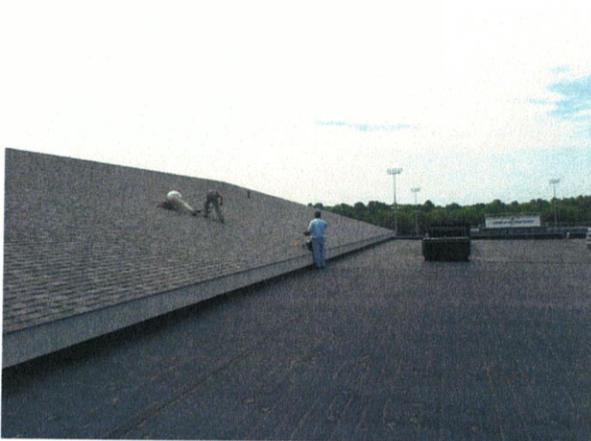
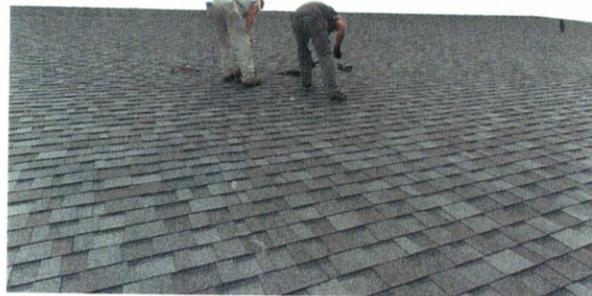
The shingles were removed from the area to expose a full 4x8 section of vent board.

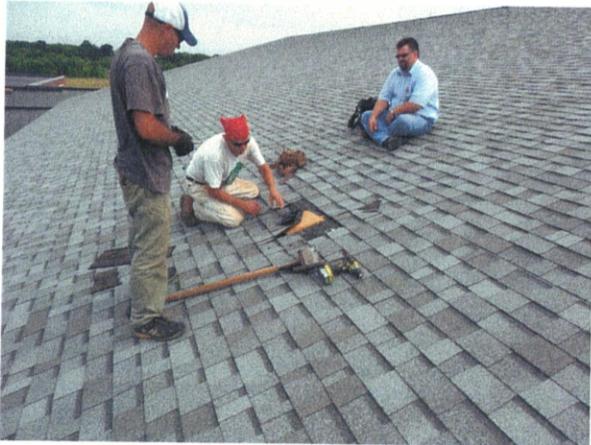
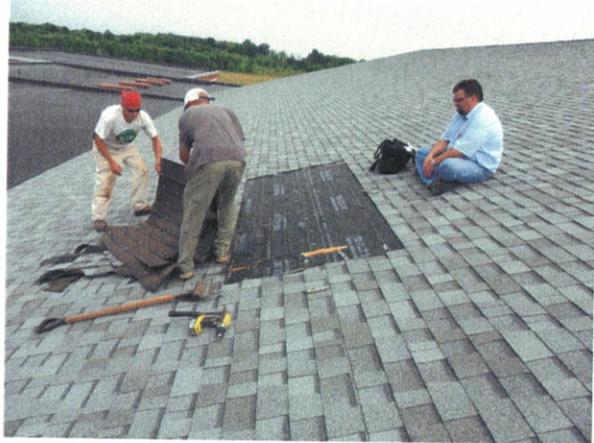
It was determined that the Tri-Flex 30 synthetic underlayment was installed at this location and secured with plastic cap nails.

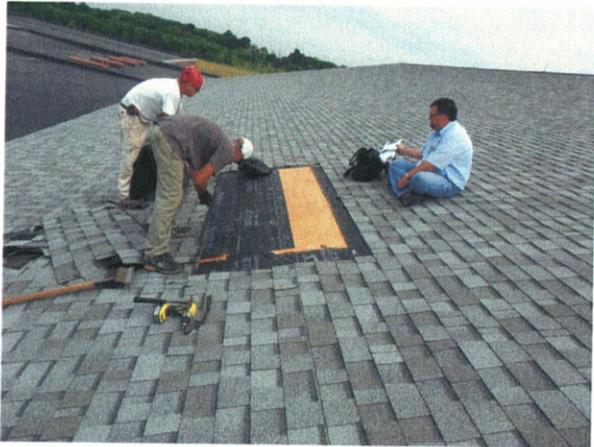
Once exposed the plywood deck was observed to be fire treated.

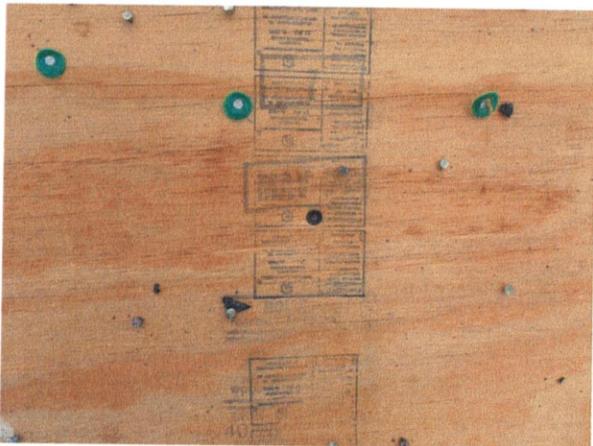
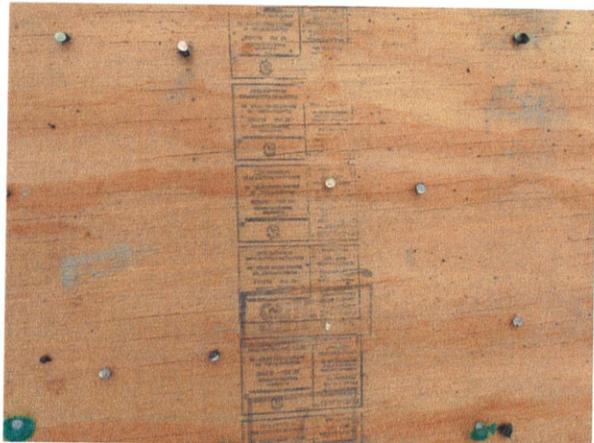
It was observed that a 5/8" gap was present along the top of the board, a 3/8" gap was present on the left hand side of the board, and 1/8" gaps were present on the bottom and right hand side of the board. This appeared to be sufficient gapping.

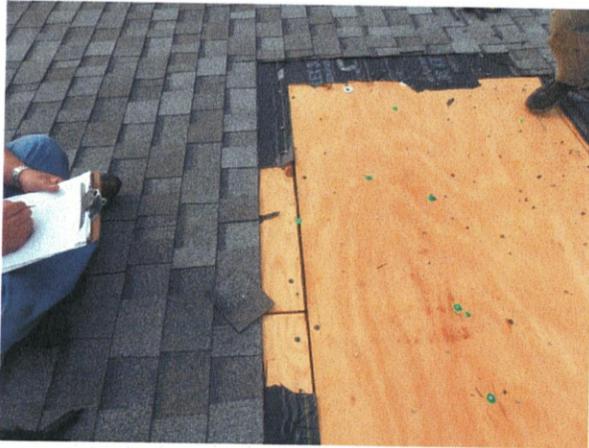
On the right hand side of the board, it was observed that three additional fasteners with plates were installed in an apparent attempt to pull down the curled end of the board. It was observed that the board was bowed in-between the fasteners.
