IN THE COURT OF CLAIMS OF OHIO

AFFIDAVIT OF ERIC MOSER

Re: Grand Valley Local Schools Roof Study

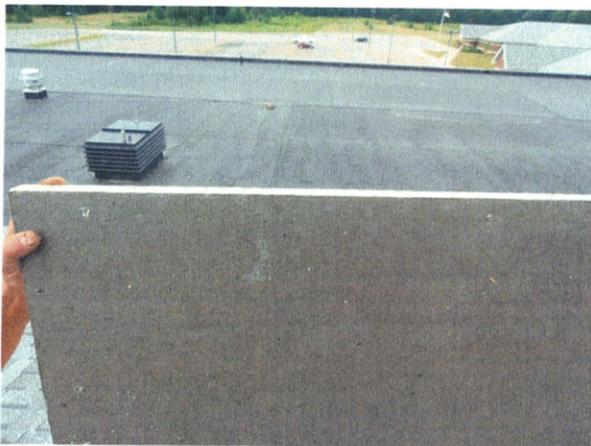
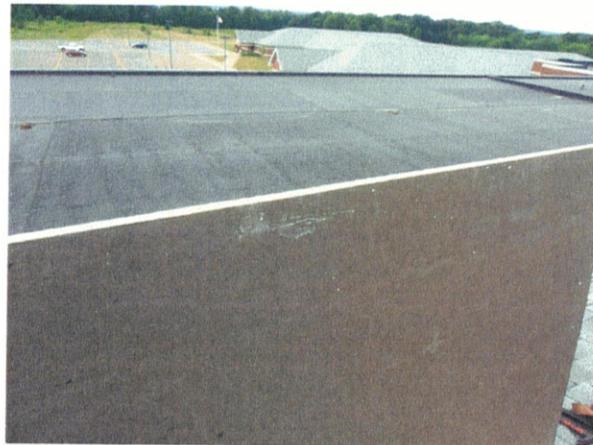
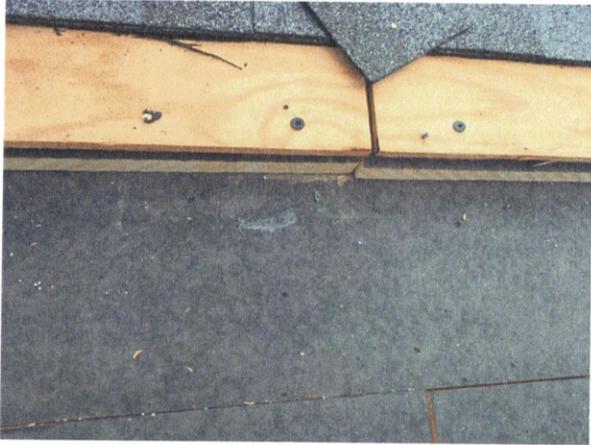
Minor water staining was observed on the bottom of the bottom layer of insulation.

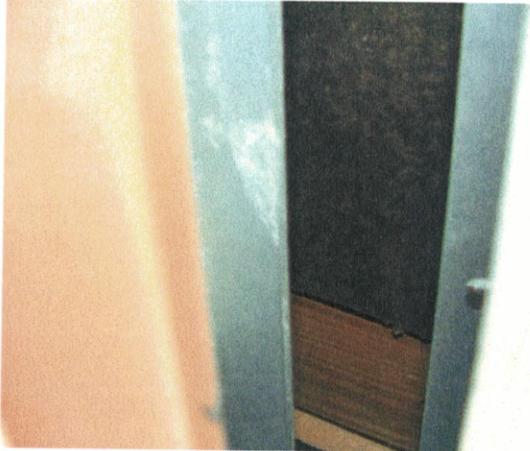
When viewed from beneath the soffit, the opening was block by the bottom layer of insulation.

Gaps were present adjoining the sleeper wood present at the soffit. These larger gaps may allow excess heat loss and contribute to the reported ice damming.

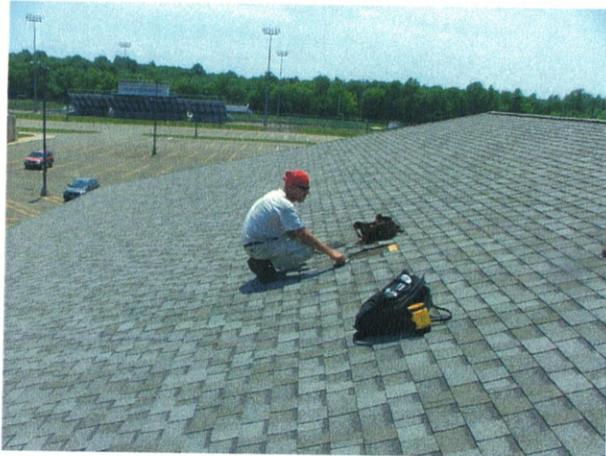
Roof Test Opening #9

RTO #9 was created on the northern end west face of Roof Face at the location of a buckle in the shingles.

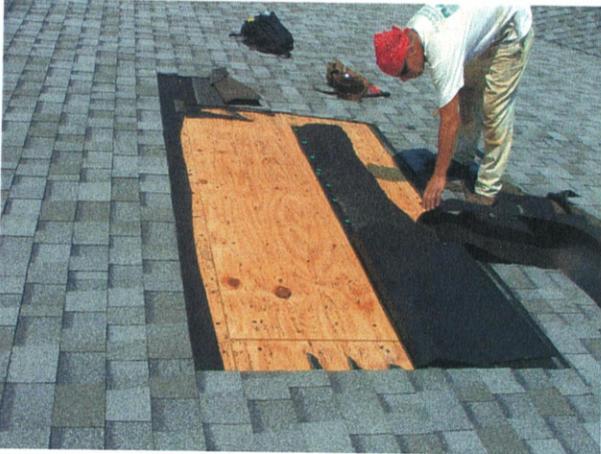
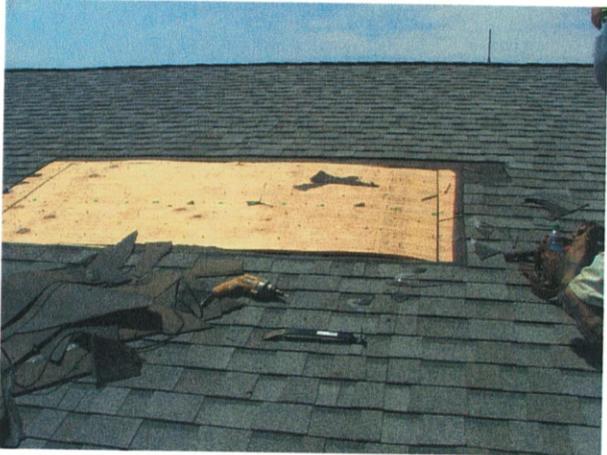
Once the shingles and #30 felt was removed from the plywood a full 4x8 board was exposed. It was determined that 15 fasteners were installed securing the board to the deck, matching the Manufacturer's requirements.

The gap present around the perimeter of the board was inconsistent. It ranged from 3/8" on two sides to nothing on the other two sides. The lack of a 1/8" on two sides may have contributed to the bowing of the plywood.

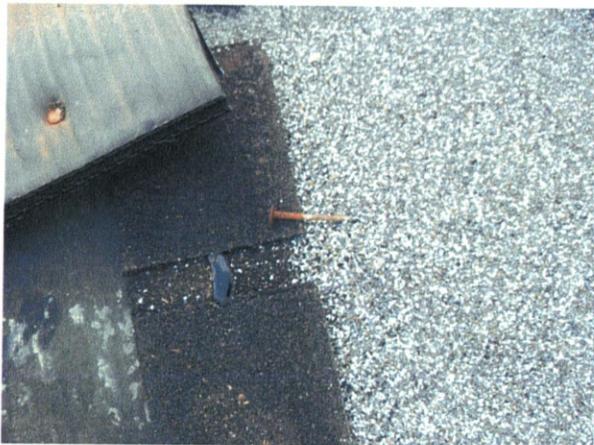
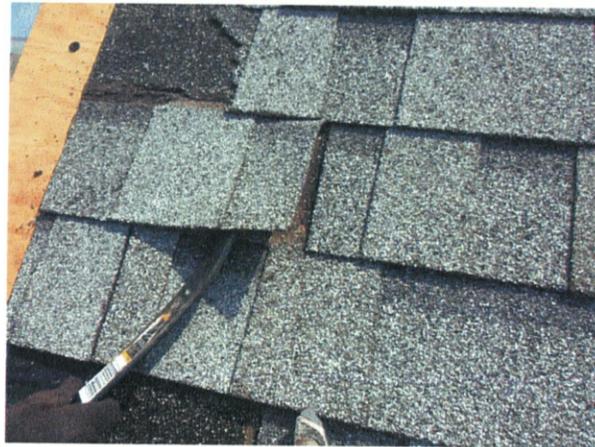
The nails used for securing the shingles were cadmium coated nails which are not an approved nail per Table 1507.2 that requires galvanized, stainless steel, aluminum, or copper nails be used.

The specifications and submittals for the project were not reviewed therefore it is uncertain what nails were specified or approved. The fasteners present have begun to rust in areas and will continue to deteriorate, especially at the locations of ice damming and leaks. In addition, throughout the roof areas nails have backed out and created holes in the overlying shingles. Each of these “nail pops” are potential points of moisture entry.

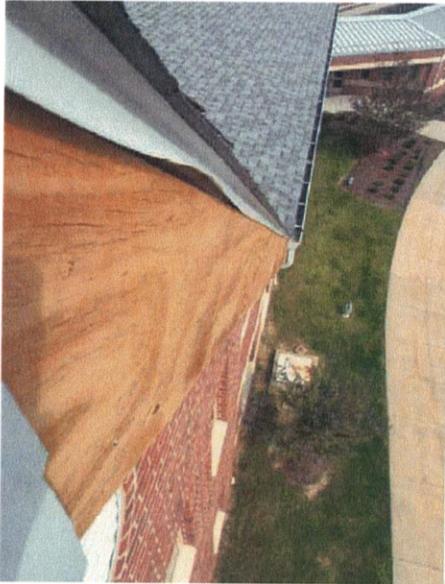
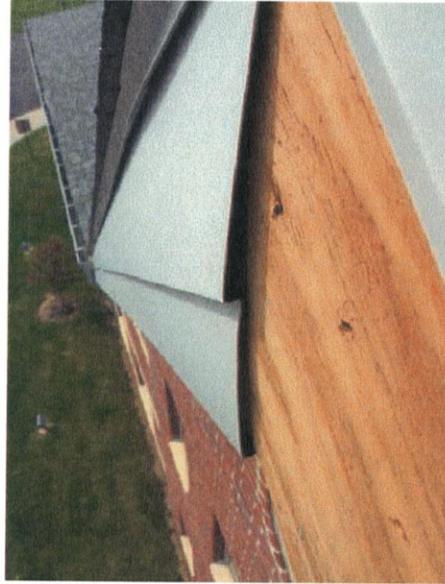
The sheet metal fascia was poorly installed. Two areas of metal were missing at the time of the site visits and the underlying wood fascia is exposed. They are marked on the drawing. It appears that no underlayment was installed over the wood at the numerous location checked during the field activities.

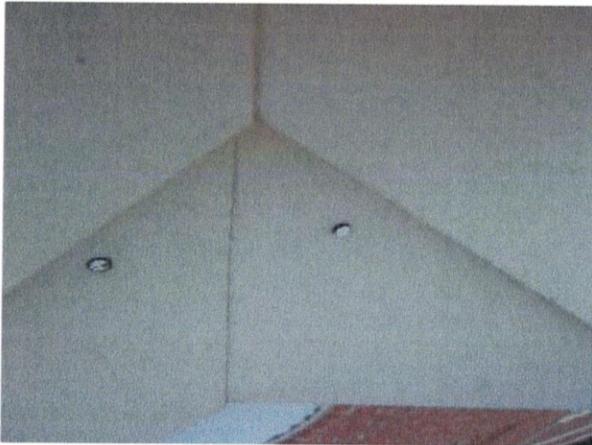
Areas were observed where exposed nails were installed to secure the fascia metal. These nails are backing out. Exposed nails should not be present in fascia since they create points of entry for moisture.

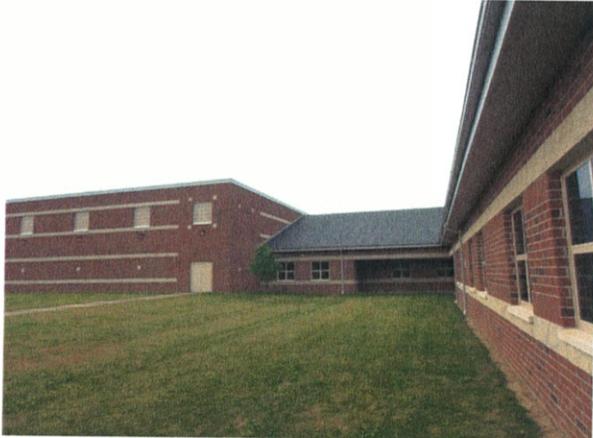
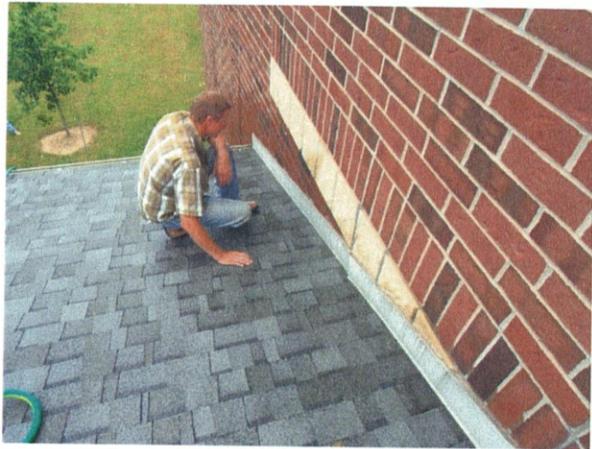
Masonry Test Opening A

MTO A was located on the north face of the eastern most location on Roof F at the masonry to roof transition. A water test was first performed on the area to attempt to determine the source of the moisture entry. Water was first applied to the field of the roof and the transitioned to the roof to wall transition. Once water hit the transition it entered the building.

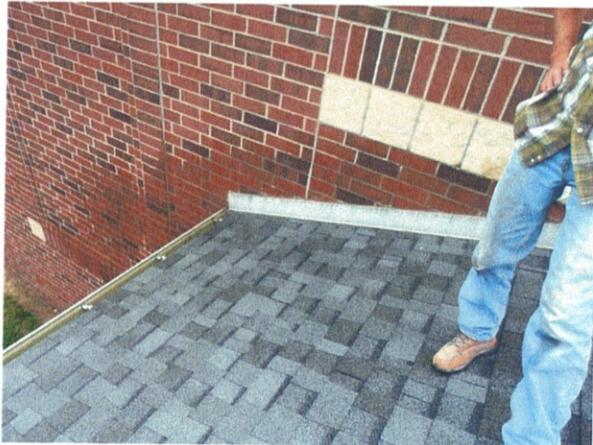
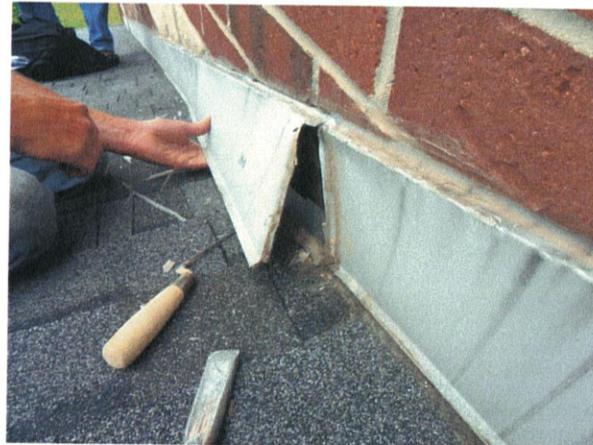
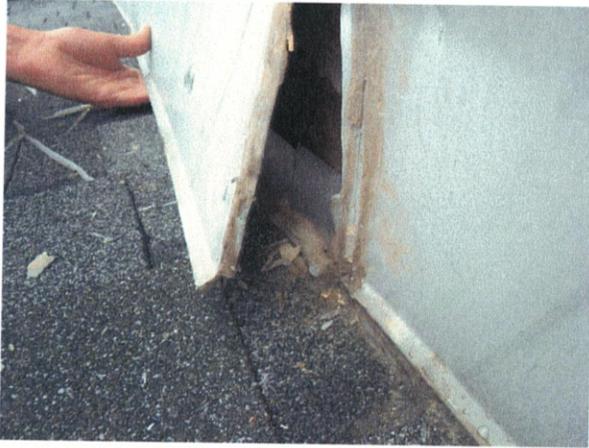
As a result of the moisture entry the sheet metal flashing was removed from the masonry wall. Once partially removed it revealed that the step tins present only had an approximate 2" up turned leg.

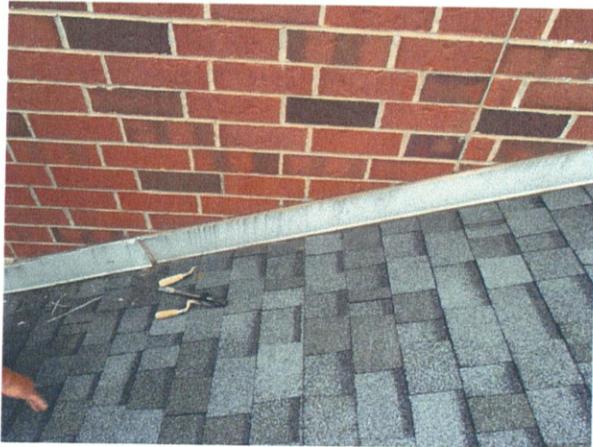
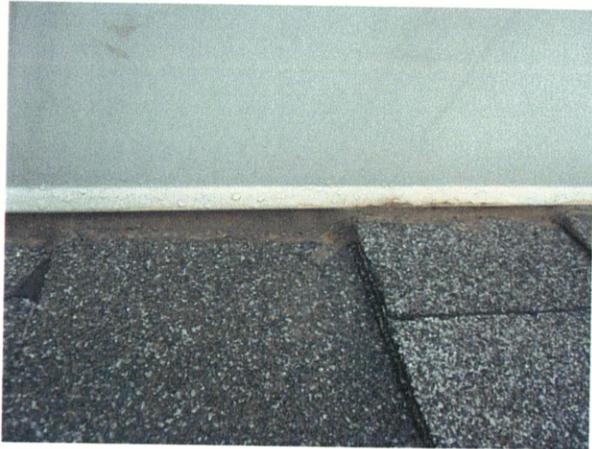
It was observed that sealant was applied to the transition of the reglet counter flashing and shingles. This is an improper repair and would have a limited lifespan.

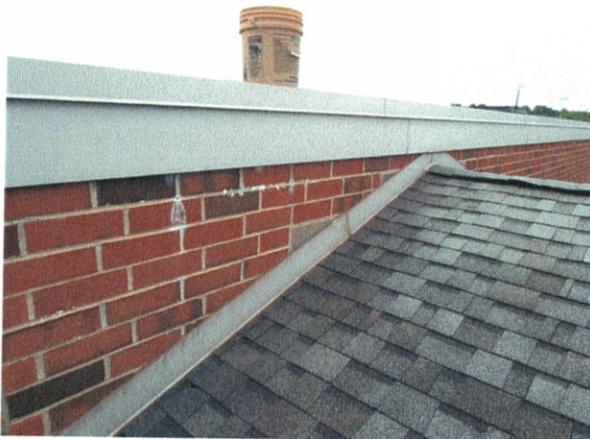
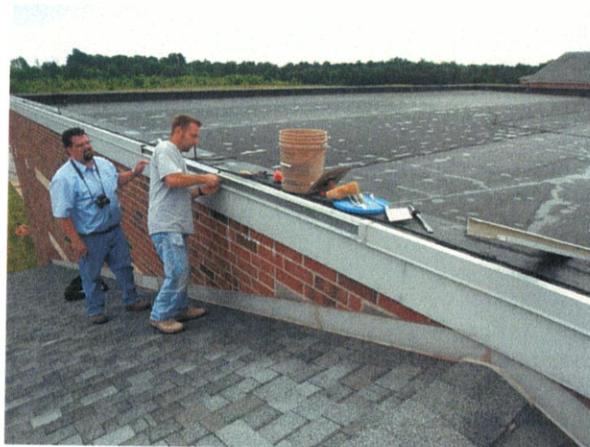
At this same location, efflorescence was observed on the masonry wall below the fascia and drip edge at the top of the parapet for the adjoining roof area. Therefore a section of the fascia and drip edge was partially removed.

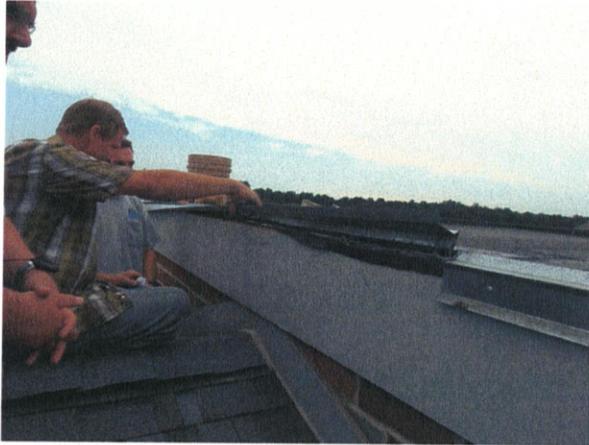
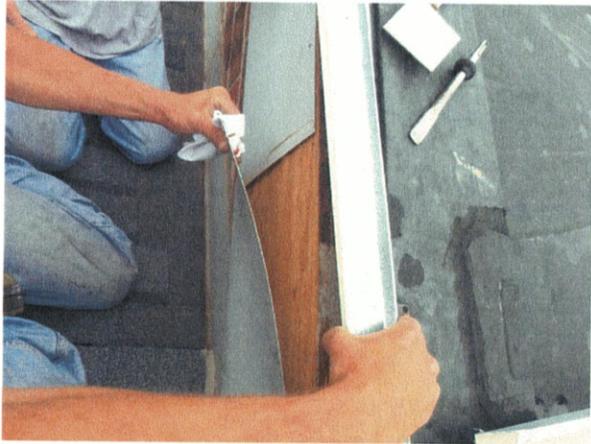
Once removed, it was observed that the EPDM membrane was cut short in areas exposing the top of the fascia metal. In addition, no protection was installed over the wood fascia prior to the installation of the metal fascia.

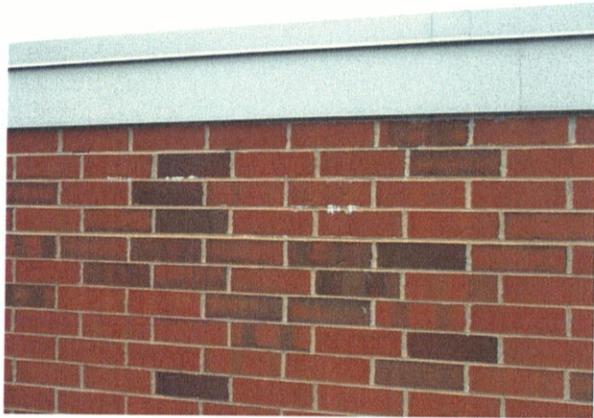
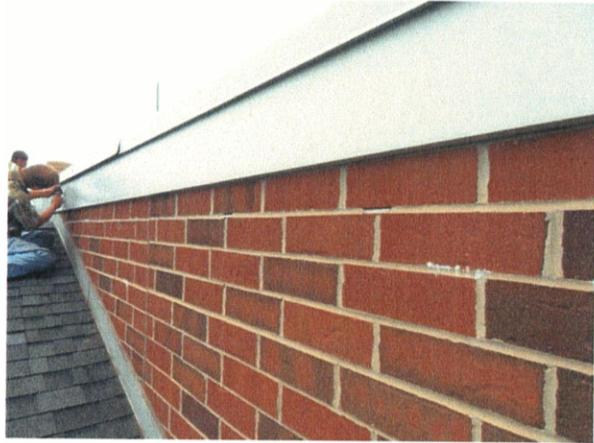
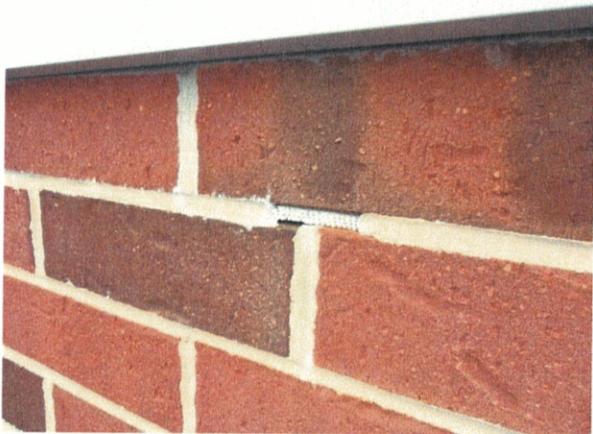
It was also observed that efflorescence was present on the southern end of the same wall. Throughout all the masonry walls, cellular head joint weeps were installed horizontally in the bed joints. The location of the weeps corresponds with some of the efflorescence observed.

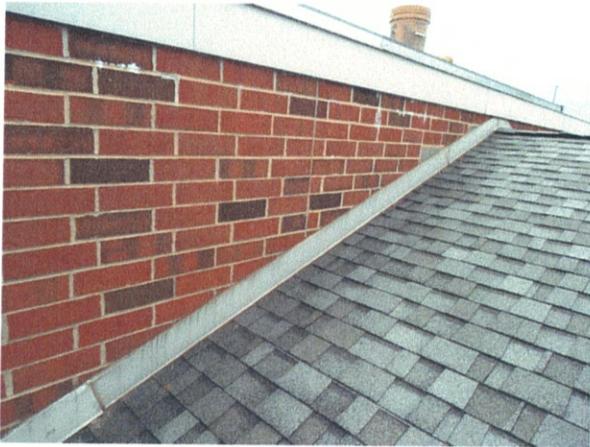
A test opening was created at the expansion joint on the northern side of the wall.

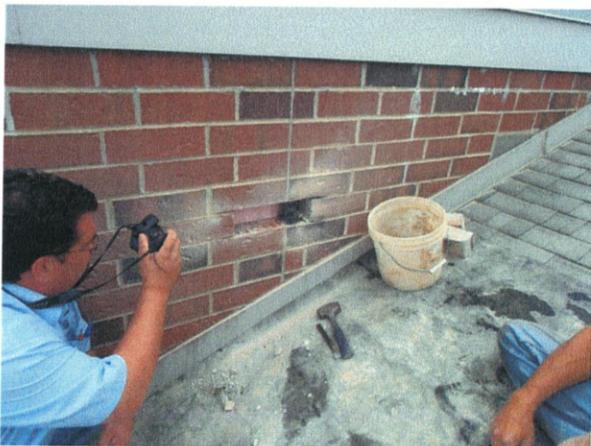
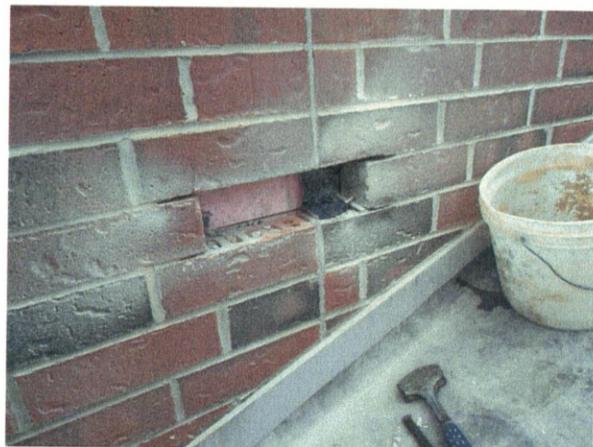
Once the opening was created, it was determined that the flashing was not continuous through the expansion joint. In addition, end dams were not present at the expansion joint. This allows any water present on the flashing the ability to drain off the ends.

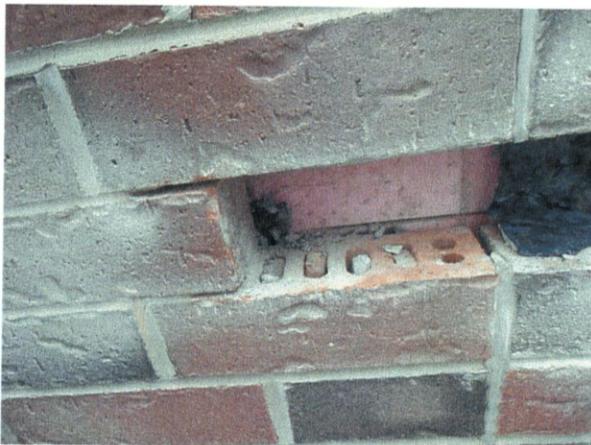
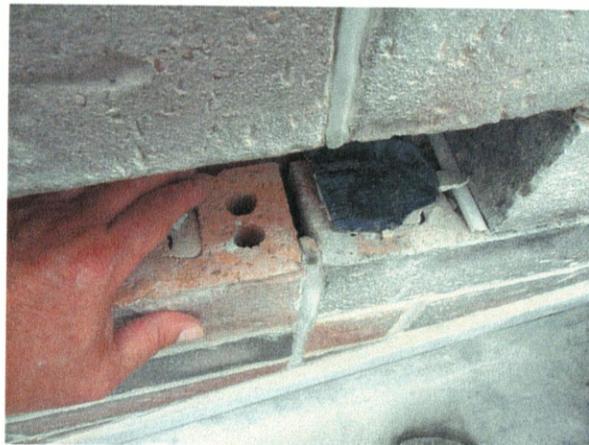
With the sealant exposed, it was determined that backing material was not installed. Without backing material, the depth of the sealant cannot be controlled. For sealant to perform properly the depth of the sealant should be twice the width.

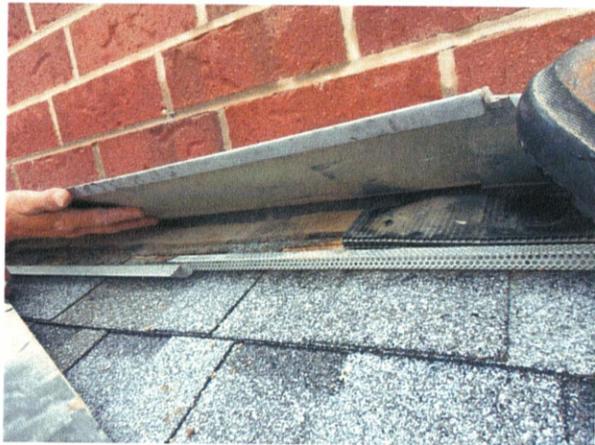
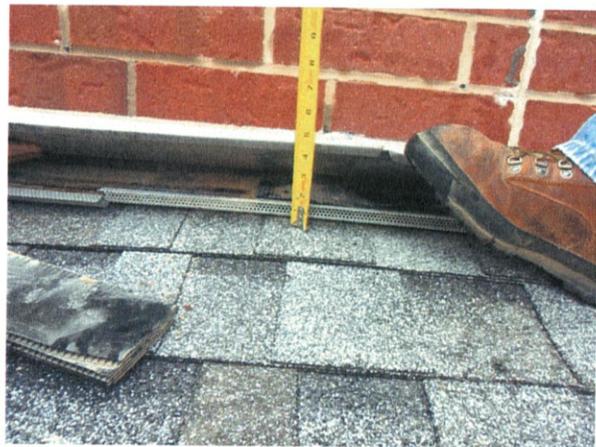
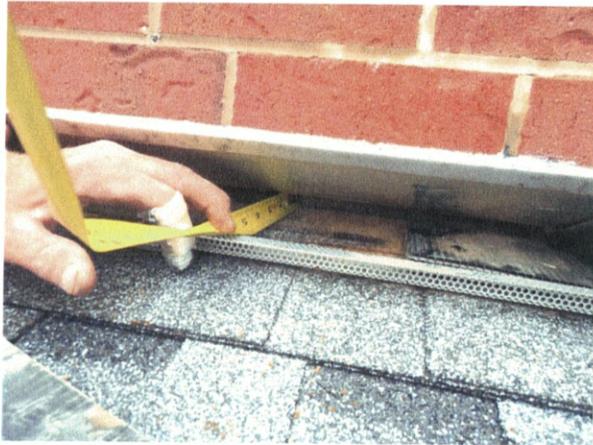
The roof to wall vent detail was dismantled. It was confirmed to be a shop formed detail that consisted of sections of apparent Cor-A-Vent PS-400, perforated metal, and a sheet metal cover. The Cor-A-Vent PS-400 is designed for vertical installation and has no means of preventing drawing rain from entering in this horizontal type of installation. As a result when the hose was directed on the vent water entered immediately.

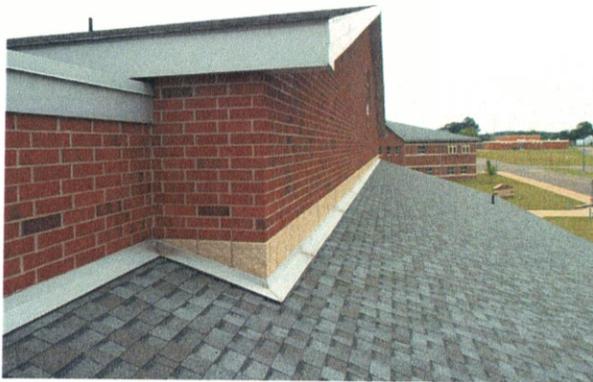
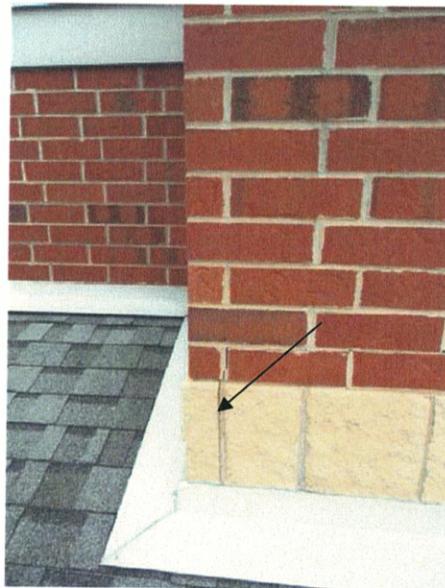
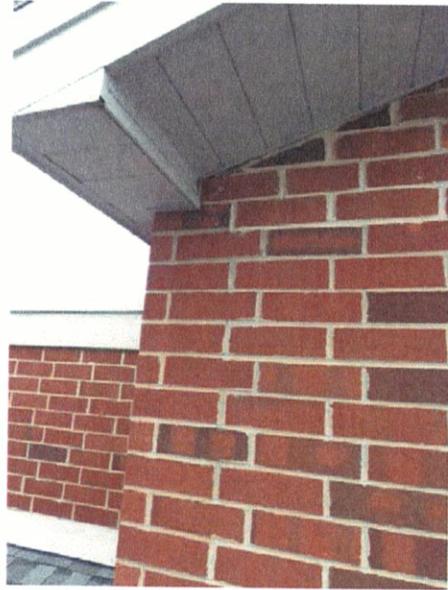
Masonry Test Opening C

MTO C was located at the southwest corner of Roof D above Roof E. A crack had developed on the southern face of adjoining this corner.

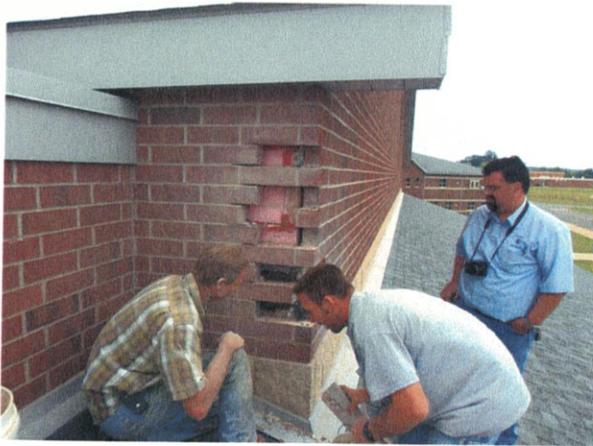
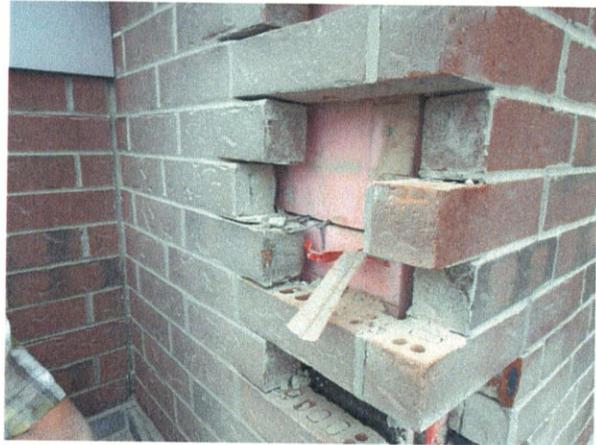
After the masonry was removed it was determined that the wall ties were spaced 16" o.c. both horizontally and vertically. In addition, a 1" air gap was present between the back of the clay brick and in front of the 3" extruded polystyrene insulation.

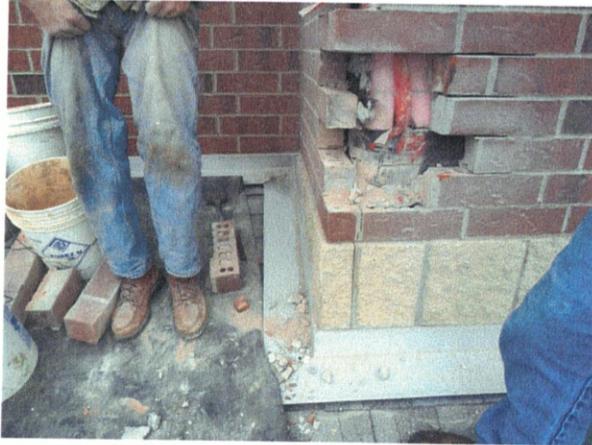
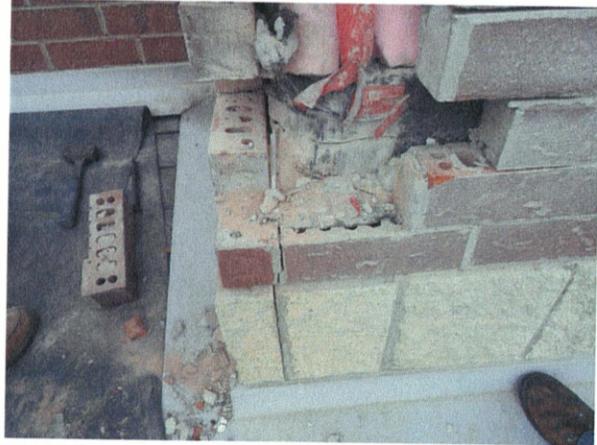
One brick course up from the split face block at the base of the wall, the through wall flashing was observed to be present. It was noted that the flashing stop approximately 1" from the face of the masonry allowing water to drain in to holes in the underlying brick unit.

The through wall flashing at the base of the masonry wall above roof line was installed improperly. Currently the flashing is too short and appears to be allowing moisture entry into the underlying wall components. In addition, weeps were observed to have been caulked. The head joints at the ends of windows sills are open. The sealant throughout the walls has begun to deteriorate. It appears some of the wall control joints sealant was incorrectly installed. As a result of these defects it is recommended that a new through wall flashing be installed at a proper height above roof line. This flashing should incorporate weeps. At restoration time all open or deteriorated mortar joints should be repaired. In addition, the walls should be cleaned and have a water repellent applied. A further masonry studied should be done to examine why some many cracks in the exterior masonry walls are developing.

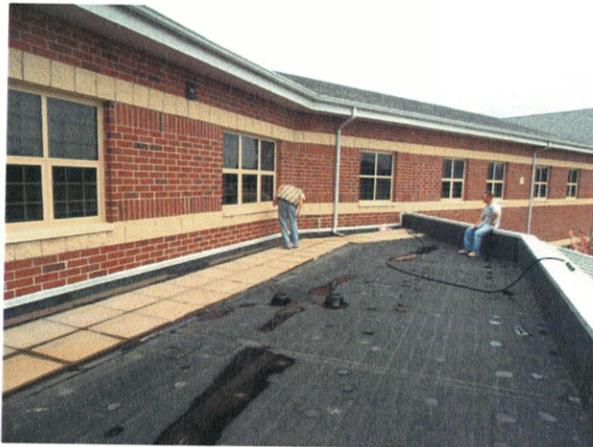
Masonry Test Opening D

At this location, over the Middle School Office Nurses Station, a water test was performed first at the northern end of the roof area. Water was first applied to the roof and flashing with no moisture entry.

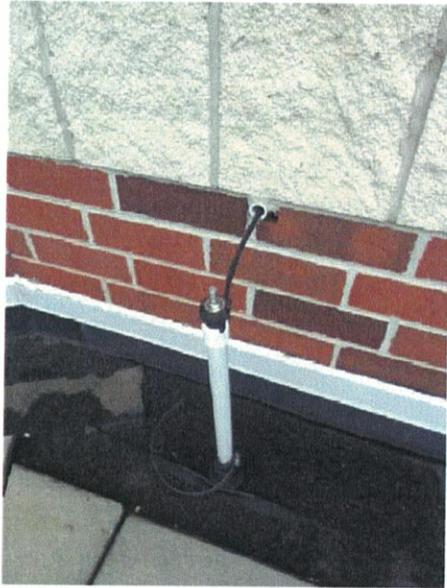
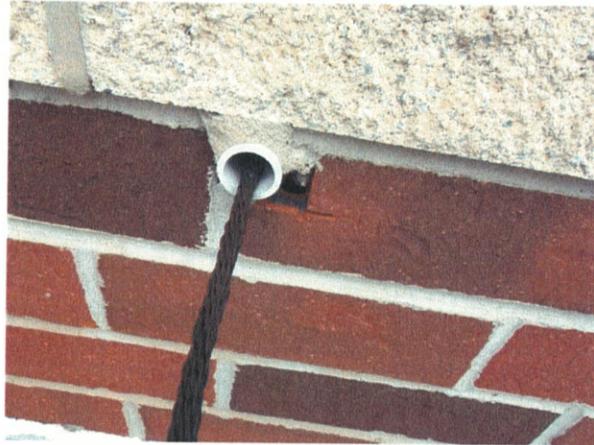
Water was then applied to the base of the masonry wall, once water was applied to the hole for the lightning protection cable water immediately entered. Based on the interior staining this was a long term point of moisture entry.

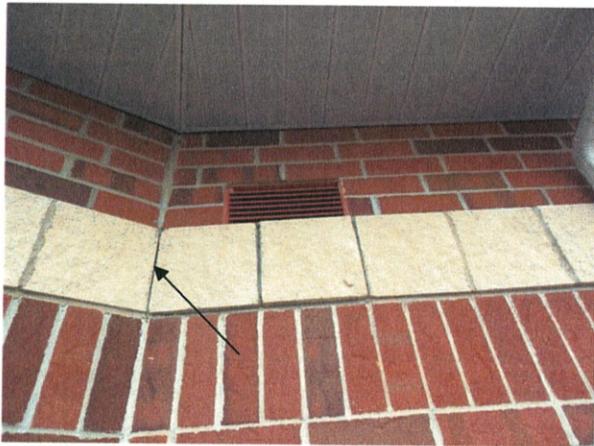
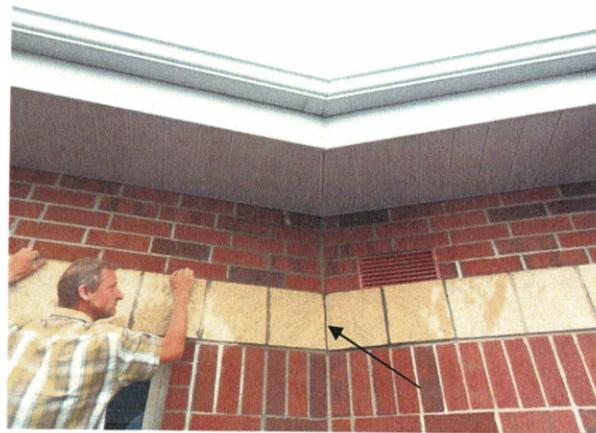
The water test was continued up the wall until the split face block ban in the masonry was reached. Once this component was reached moisture again entered. It was determined that mortar was never installed in the joint between split face block and the inside corner.

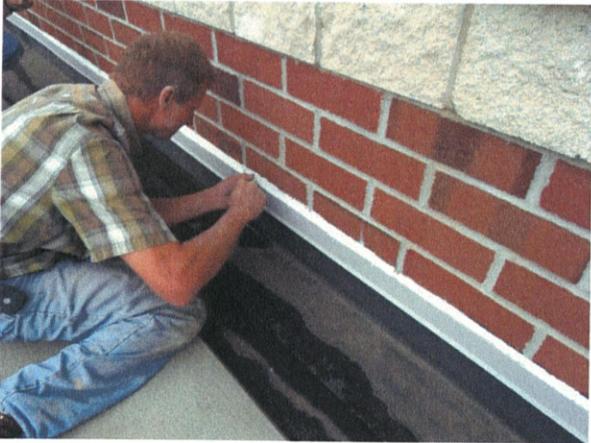
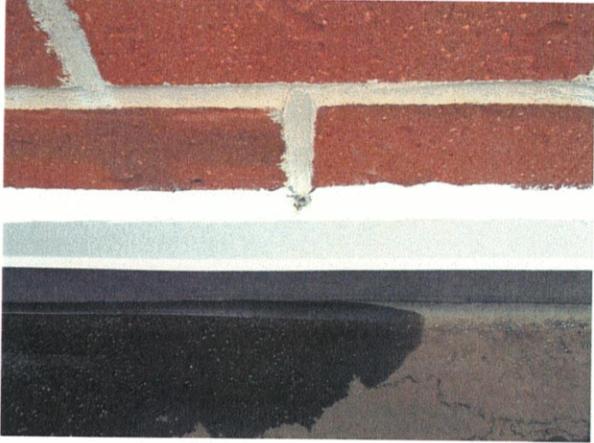
The water test was then moved further to the south on the wall and moisture was found to enter once water was applied to the wall at an elevation approximately at the window sill. Multiple items were observed in these areas that may have been contributing to the moisture entry. At some point someone installed sealant over the weeps present at the base of the wall. With the weeps closed moisture that is absorbed by the wall has no means of exiting.

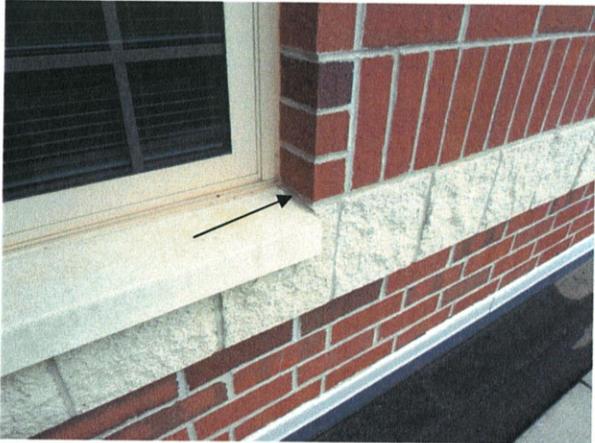
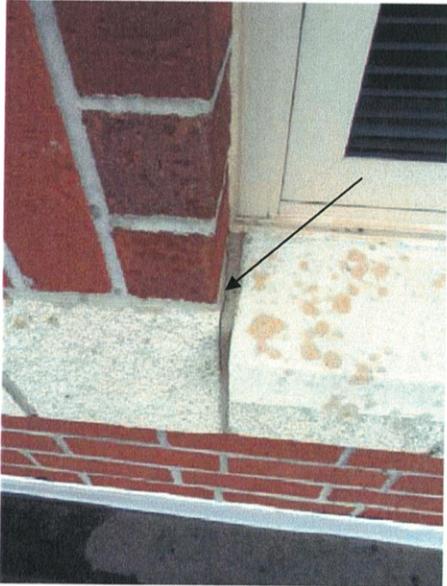
In addition, at either end of the precast sills the mortar joints are open.

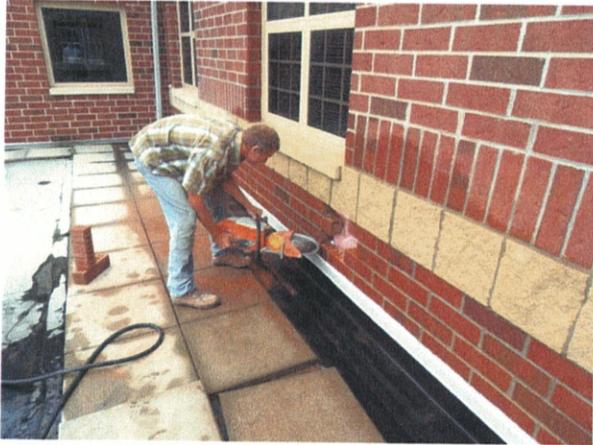
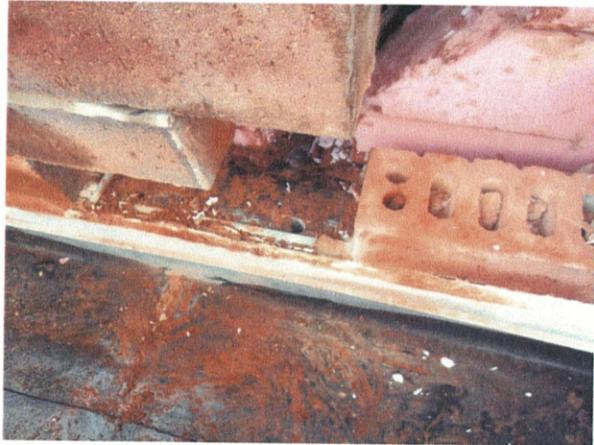
An opening was created directly beneath northern end of the second window north of the skylight. When the bricks were removed it was determined that the flashing stopped approximately 1" short of the face of the brick units leaving the cores of the brick units exposed. This allows water that is being forced out by the flashing to drain into the cores of the underlying brick units.

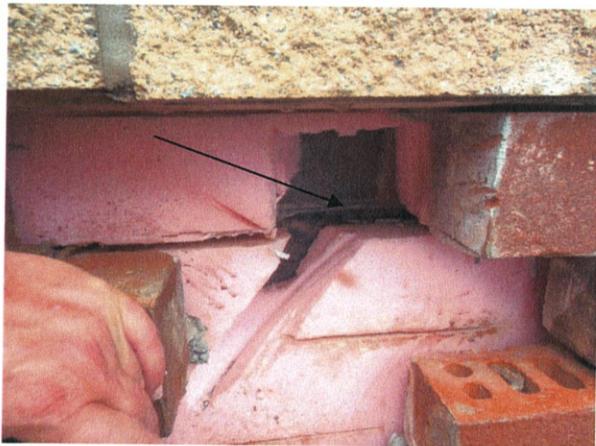
With the brick and extruded polystyrene removed it was observed that the flashing was installed in the mortar joint of the backup CMU.

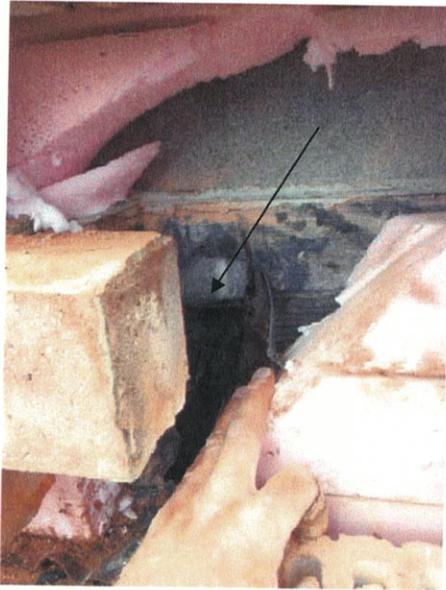
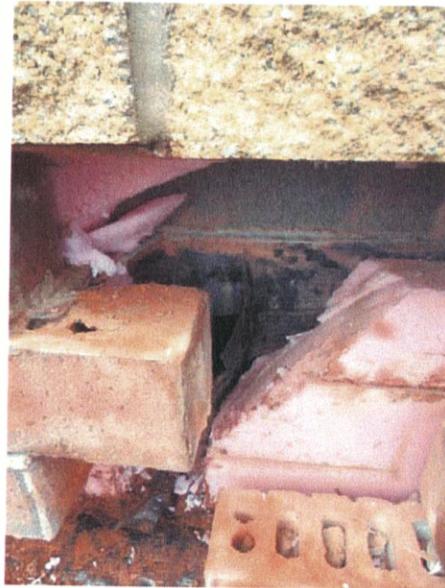
When the flashing was cut open it was determined that two pieces of flashing were used to create the detail. With the large amount of overlap observed it appears that the contractor could have easily moved the bottom piece of flashing down to allow it to be exposed and cover the underlying brick.

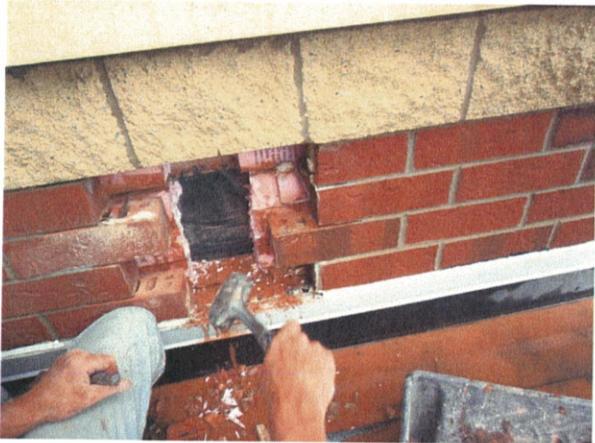
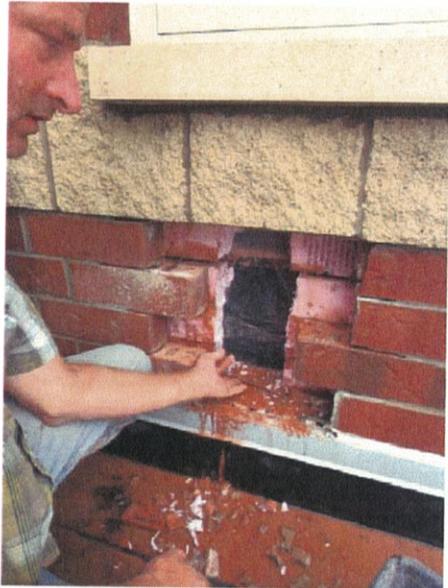
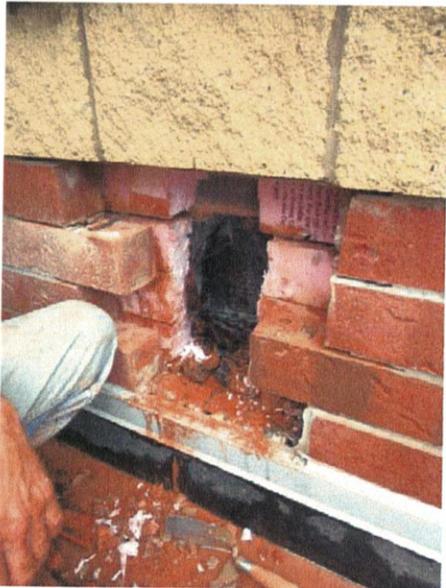
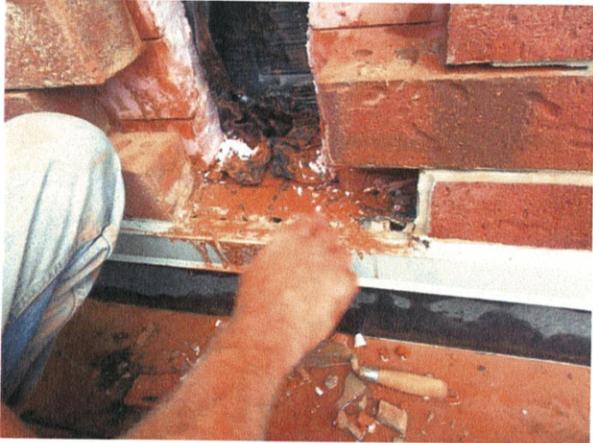
With the masonry and extruded polystyrene removed, the through wall flashing was exposed. The condition of the flashing matched that at MTO D, the flashing stops short of the exterior masonry wall exposing the cores of the underlying masonry units. In addition, the end laps in the flashing were not adhered.

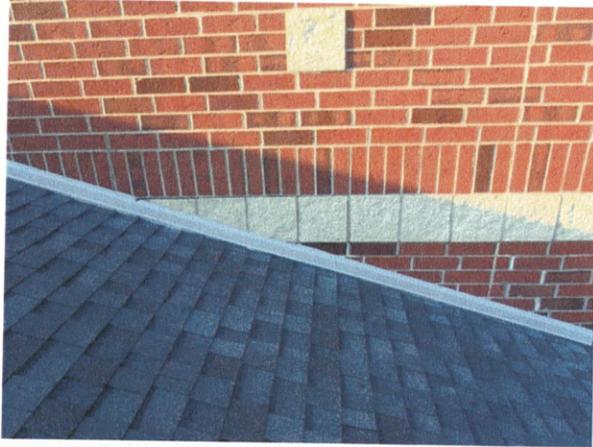
Wall above Roof C

On July 21, 2011, an additional site visit was made to view the conditions of Roof C and the adjoining masonry wall components above Roof C. Numerous step cracks are present directly above the through wall flashing in the masonry.

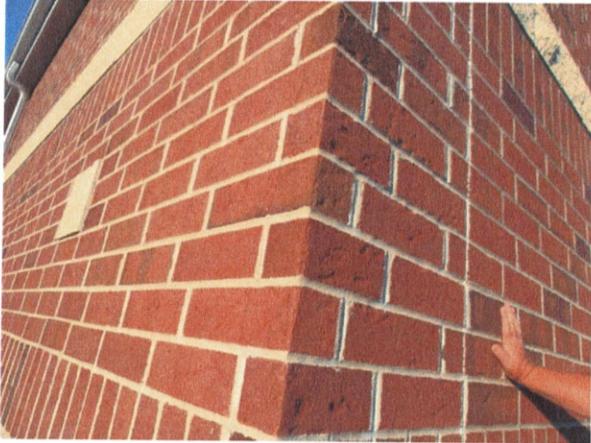
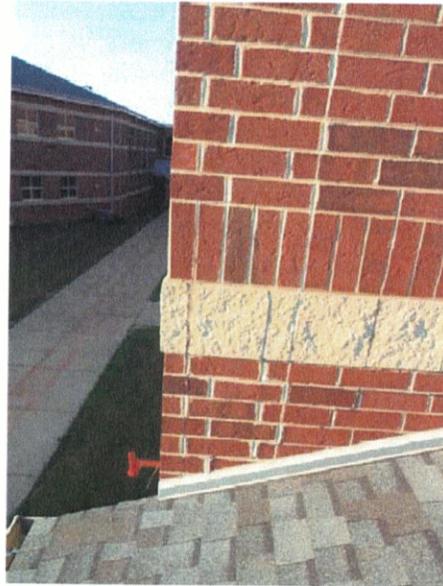
In addition, apparent expansion relief cracks have developed at the corners.

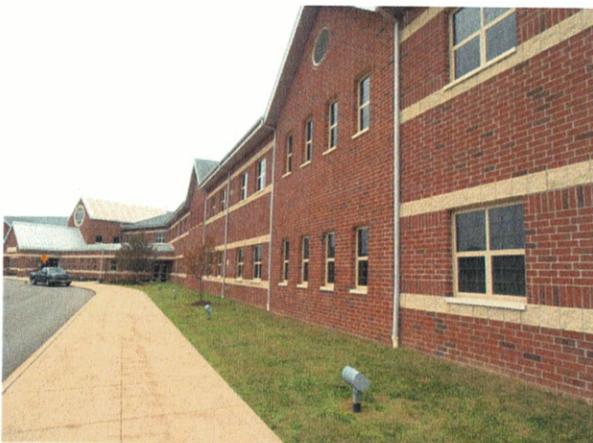
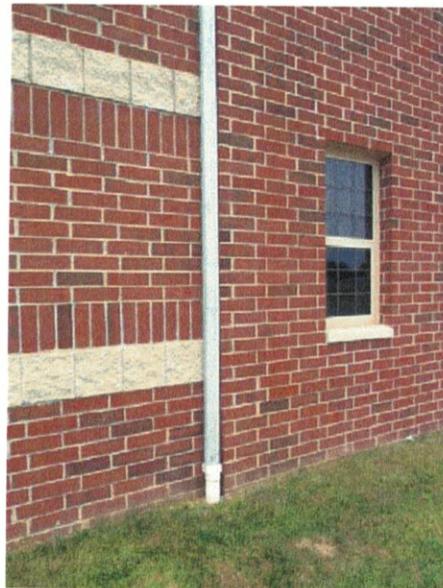
Control Joints and Vertical Cracks

When the perimeter of the building was viewed, numerous vertical cracks were present, especially at the masonry present below the dormers on the east side of the building. The presence of these cracks implies that this building needs additional capacity to absorb movement. These cracks will continue to deteriorate and further masonry deterioration may develop if this situation is not further investigated and properly resolved.

During the study it was observed that portions of the building have long lengths present without apparent expansion joints visible. **A Structural Engineer should be hired to determine if adequate expansion joints are present in the construction of the building and its roof systems. In addition, the Engineer should determine if the movement observed has affected the attachment of the roof system and deck components.**
